Field Review Memo

To: Megan Hickey, BPI, L&M Engineering Limited
From: Hans Jorgensen, P. Eng.
Date: September 29, 2021
Project No.: 21-P-016
Re: Slope Review: Lot 1 District Lot 2424, Cariboo District, Plan 27163 (PID 006-595-456)

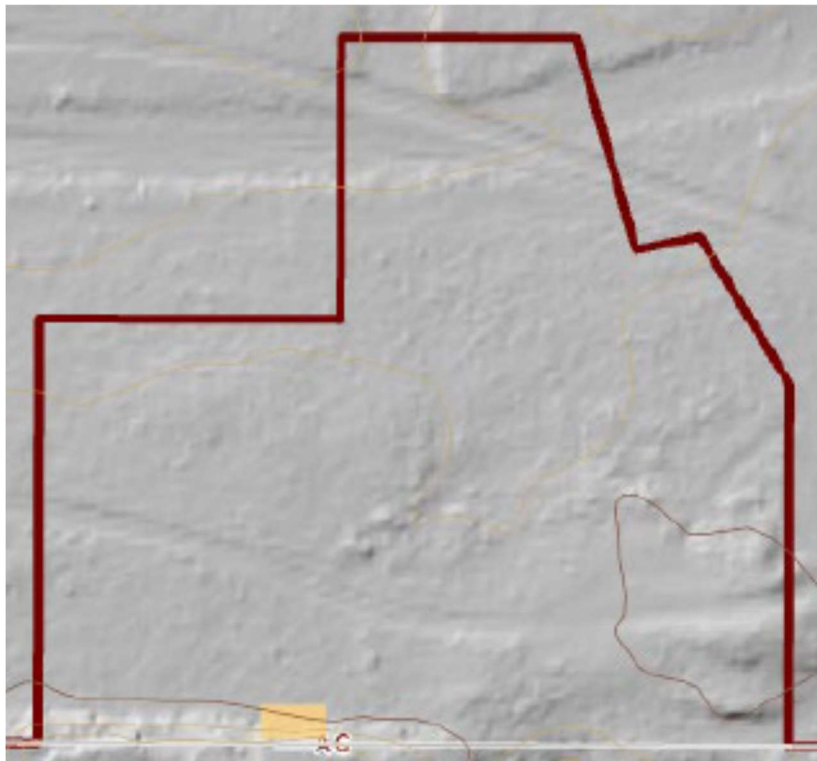
Figure 1. Significant slope area highlighted on PGMap Lidar (2014) imagery

L&M provided a drawing (Drawing No. SP their Project No. 1113-10) outlining the boundaries of the proposed lots and profiles of two sections of the slope taken from PGMap 2014 Lidar information. The drawing indicates the slope is located along the south boundary of several of the future lots. The slope profiles show the maximum slope grades to be approximately 40% and the hill to be about 30 m wide.

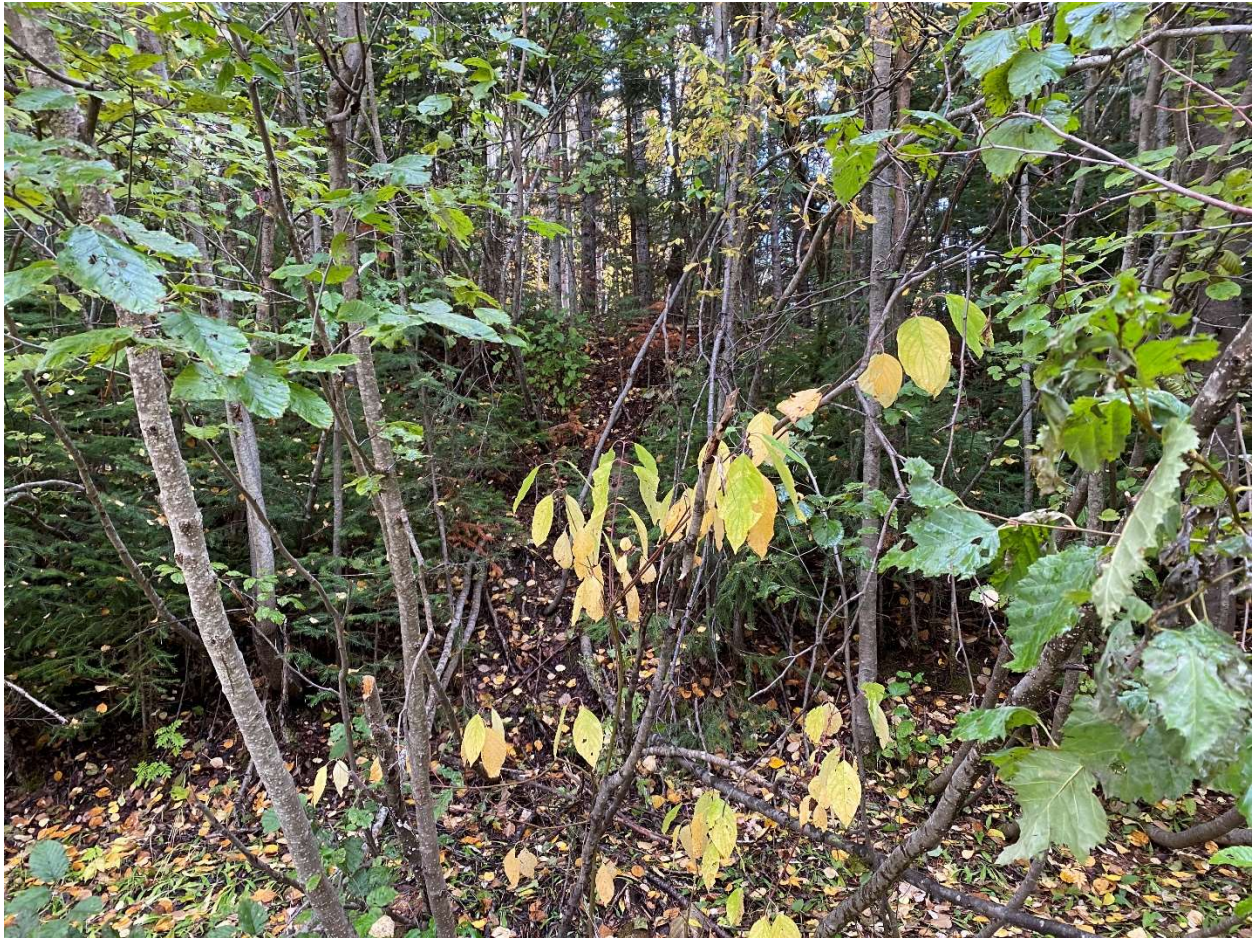
On September 27, 2021 we visited the site to review the slope and soil conditions in the area. The slope has a maximum height of approximately 3 m and appears to be cut from previous earthworks on the property. It is well vegetated with immature trees as shown in Figure 2. We measured the steepest section of the slope to be between 40% and 65% with a handheld inclinometer. We reviewed soil conditions and collected soil samples from two hand dug test pits along the two slope profiles. We performed sieve analyses on the samples (laboratory reports attached). Soil conditions near the surface of the slope consisted of stiff silt, sandy to some sand, and were consistent with soil throughout the subdivision. No tension cracks or signs indicating deep seated or surficial movement were observed during our review.

Figure 2. Looking southeast at a portion of the slope. Photographed September 27, 2021.

The slope shows no signs of surficial instability or movement. The existing slope angles are suitable for the given conditions and no remediation is necessary if left in their current state. If it is desirable to regrade the slopes or remove the vegetation, they should be regraded at 2 Horizontal to 1 Vertical (2H:1V).

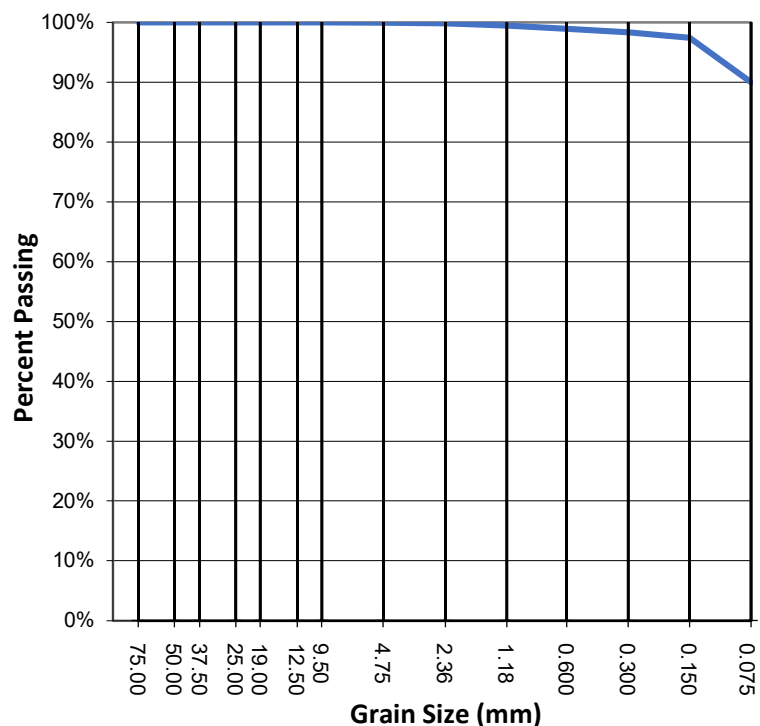
Project No. 21-P-016
Sieve Report No. 1

Supplier Existing
Source Slope Profile B
Location Mid Slope
Description Silt
Specification

Sieve Size (mm)	Percent Passing	Specifications	
		Min	Max
75.0	100.0%		
50.0	100.0%		
37.5	100.0%		
25.0	100.0%		
19.0	100.0%		
12.5	100.0%		
9.5	100.0%		
4.75	99.9%		
2.36	99.8%		
1.18	99.4%		
0.600	99.0%		
0.300	98.4%		
0.150	97.5%		
0.075	90.0%

Moisture Content 8.2%

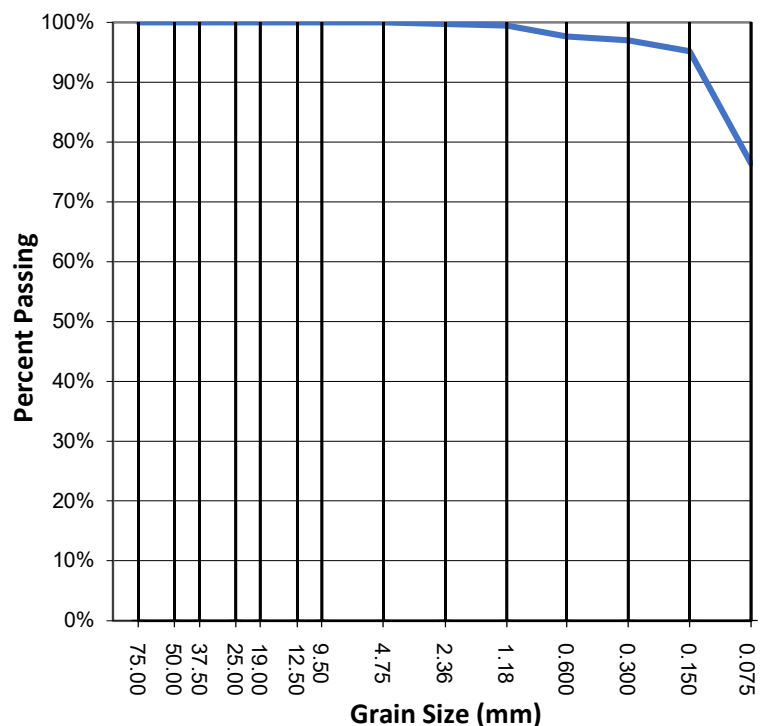
Project No. 21-P-016
Sieve Report No. 1

Supplier Existing
Source Slope Profile A
Location Toe of Slope
Description Silt
Specification

Sieve Size (mm)	Percent Passing	Specifications	
		Min	Max
75.0	100.0%		
50.0	100.0%		
37.5	100.0%		
25.0	100.0%		
19.0	100.0%		
12.5	100.0%		
9.5	100.0%		
4.75	100.0%		
2.36	99.7%		
1.18	99.4%		
0.600	97.7%		
0.300	97.0%		
0.150	95.2%		
0.075	76.4%

Moisture Content 9.6%
