January 29, 2020

File No. K-5302

**Re: Geotechnical Assessment,
4244 Foothills Boulevard, Prince George, B.C.**

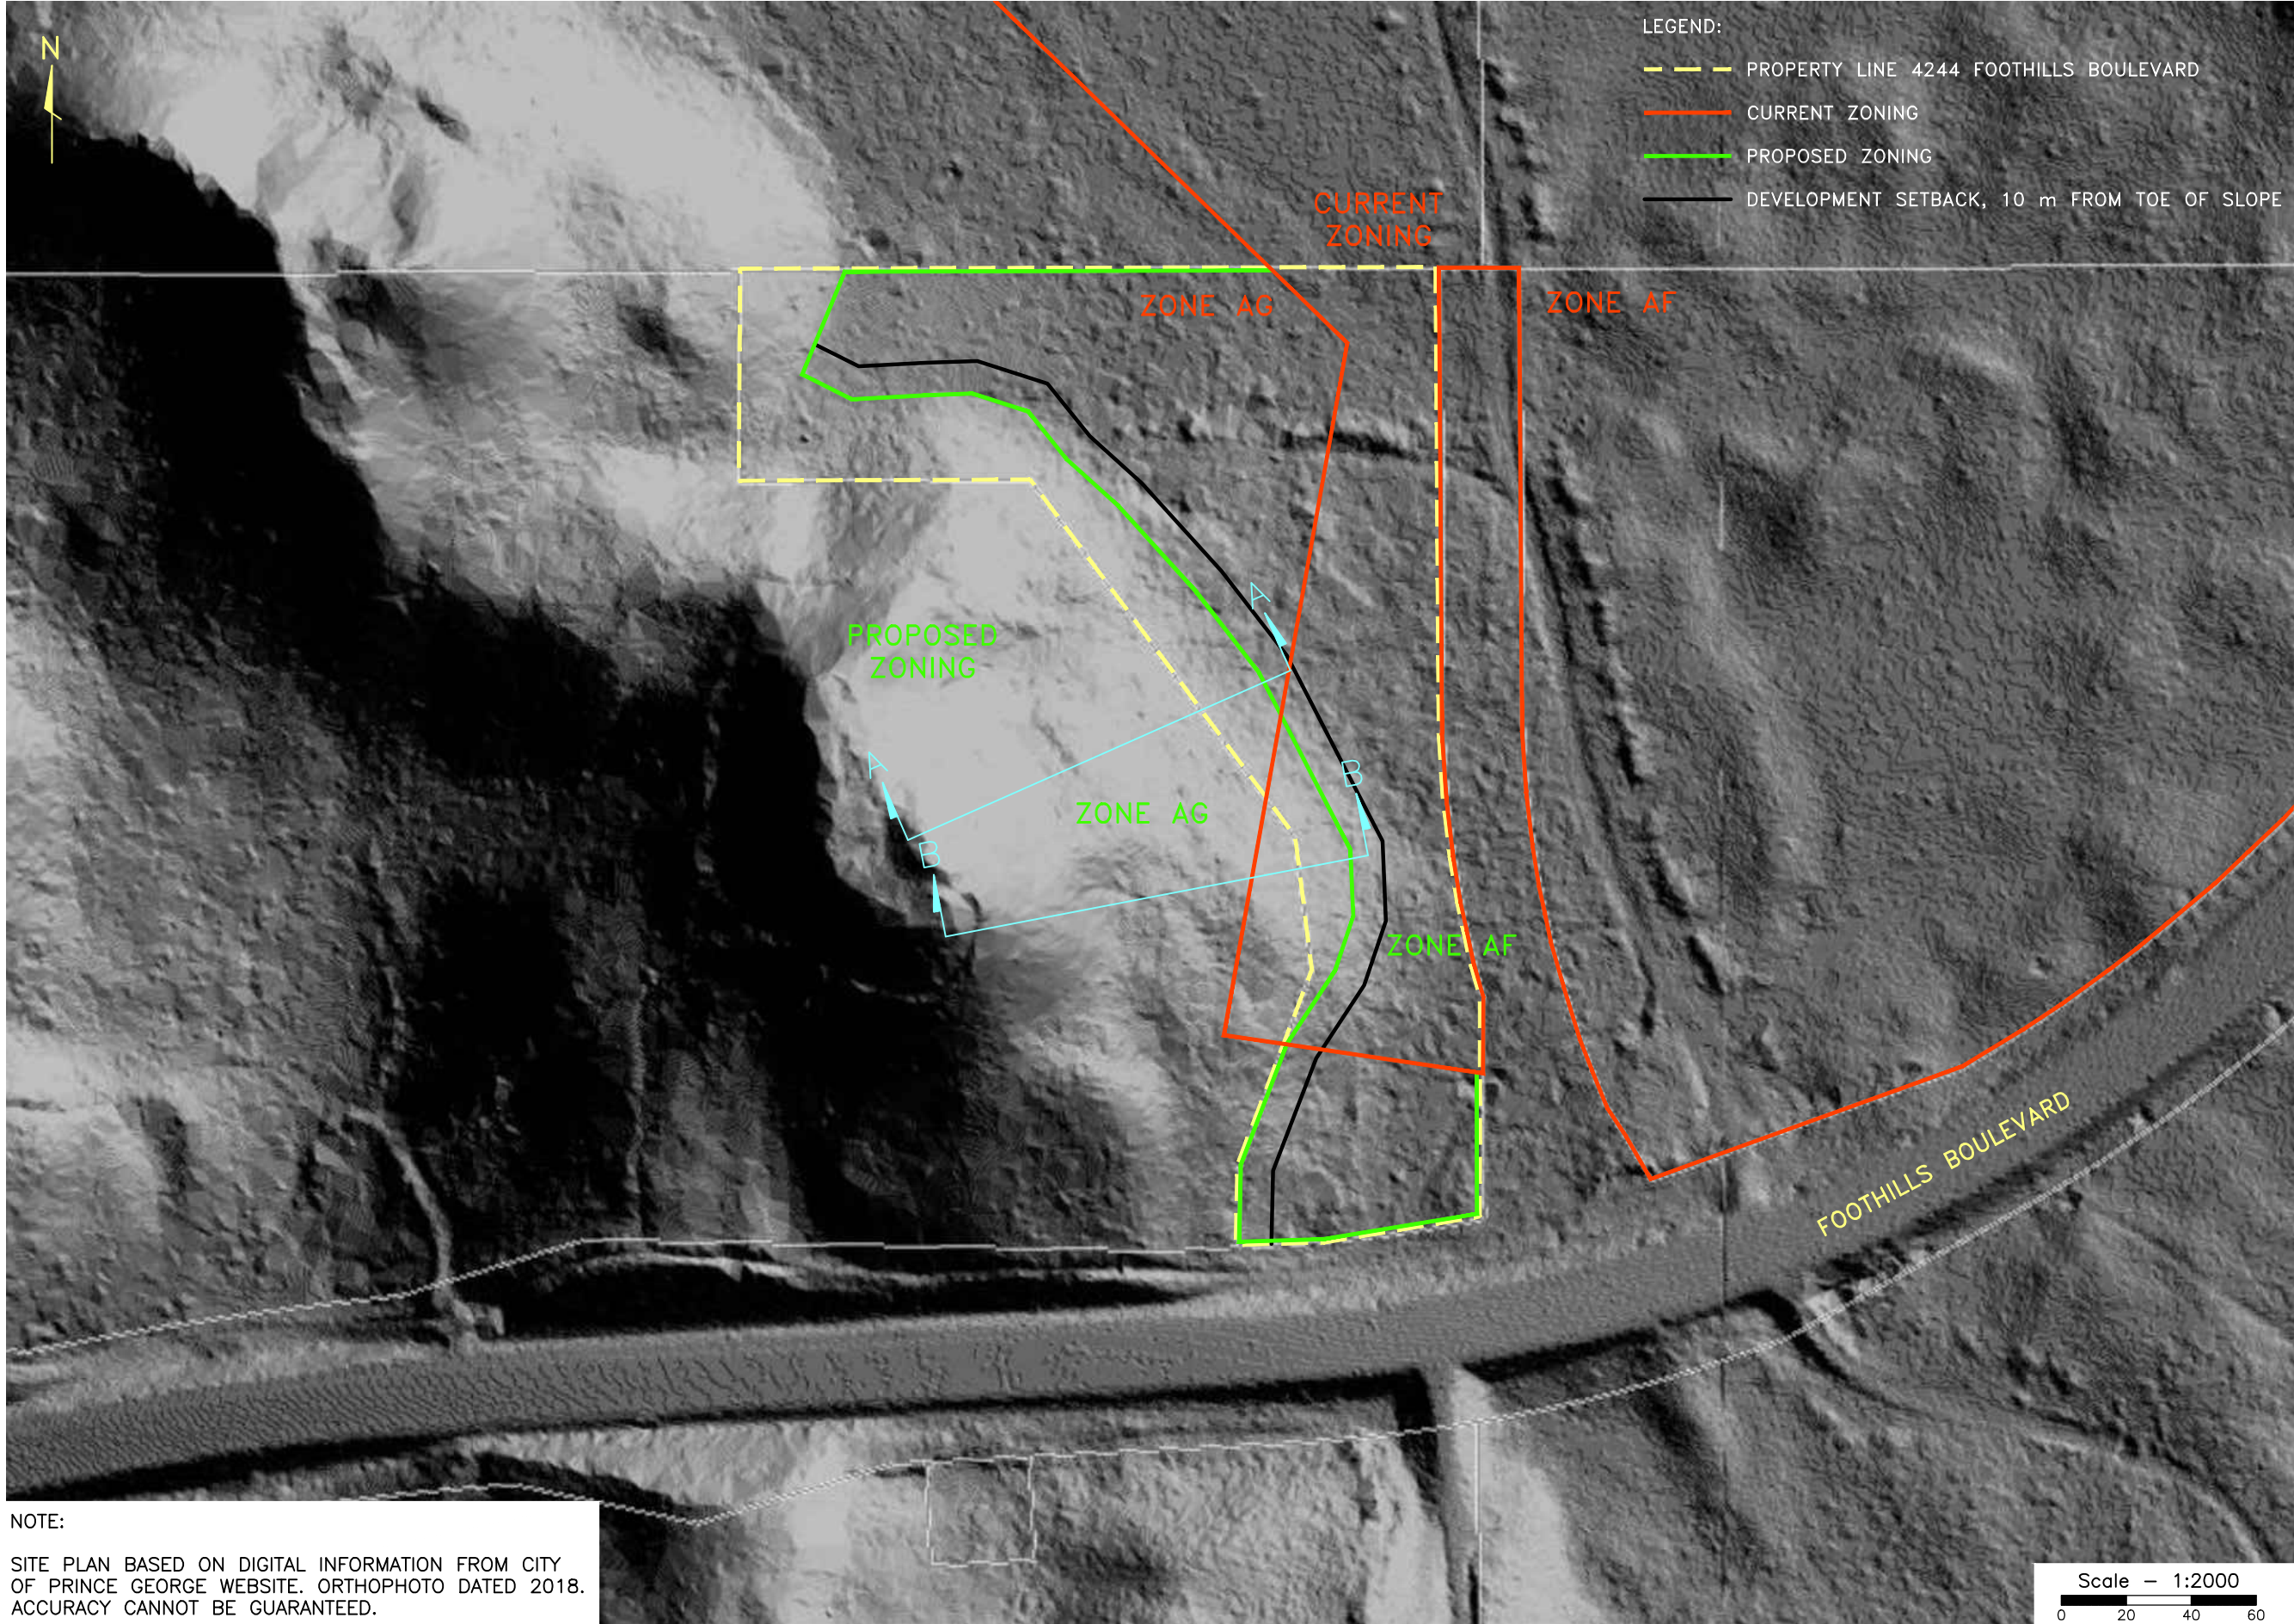
DRAWING NO: 5302-A2

Contour maps show terrain below the east part of the property is relatively flat, between elevations 662 and 665 m. The west part of the property is located partly over the toe of a conical shaped hill, a kame, with moderate to steep gradients that extends up to elevation 722 m. The slope is 100 m long, has a concave profile and shows no signs of sliding. The lower part of the slope has moderate gradients between 35 and 50%, the mid part of the slope has moderately steep to steep gradients between 50 and 70%, and the top part of the slope is steep with gradients over 75%. A skid trail circles the hill and accesses a flat pad constructed at the top of the slope. The trail was constructed by excavating and side casting fill over the natural slope, resulting in a nearly vertical 3 m high pitch at the top of the slope. Behind the slope crest, the ground slopes west, away from the project area at a gentle gradient. A hillshade image is shown on Drawing 5302-A2, attached.

As noted above, there are no indications of previous shallow or deep-seated instability upslope of the area proposed for house construction, but there are indications of surface soil erosion at the crest of the 100 m long slope. The erosion is a result of runoff along wheel ruts in the access trail leading to the top of the slope. The 3 m high, nearly vertical pitch at the crest of the slope could fail as a slump or blocks could topple, but the debris runout is unlikely to have sufficient kinetic energy to reach the toe of the slope. There is no evidence of intact blocks of silt, nor are there indications of previous debris flow activity on the slope.

and the potential for damage to buildings caused by runoff and sedimentation can be mitigated by leaving a space between proposed occupied structures and the toe of the slope. We recommend a setback for residential buildings of no less than 10 m measured from the toe of the slope.

The transition in zoning between AG and AF at the time of writing does not follow a property line, a drainage, or terrain feature and seems to be arbitrary. From a geotechnical perspective, we recommend revising the zone boundary to that shown on Drawing 5302-A2.

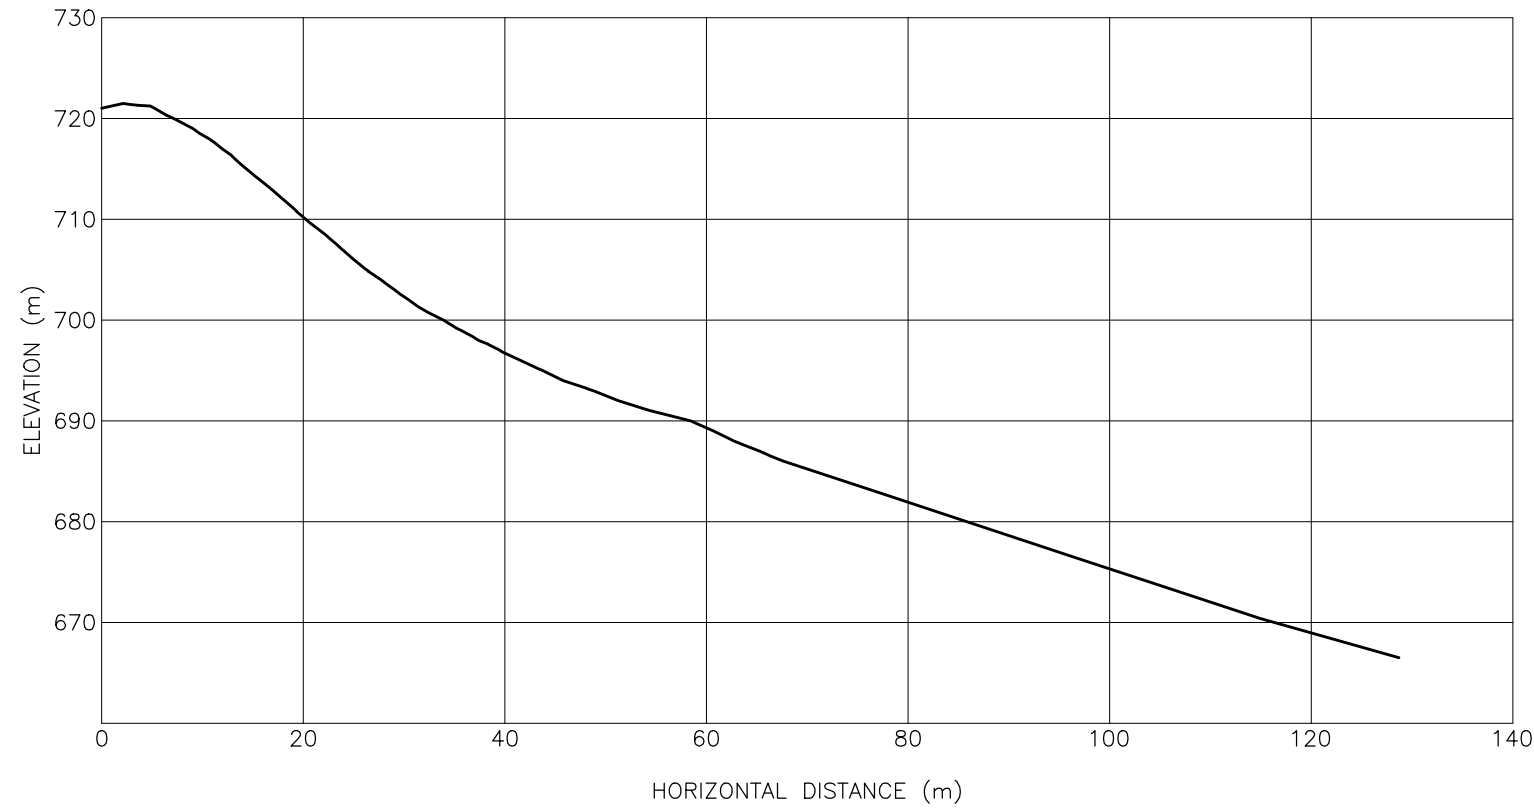
CROSS SECTION A-A

Cross sections from hip-chain and clinometer readings taken during the site assessment and from ground contour information from the City of Prince George website are shown on Drawing 5302-A3, attached.

Soil conditions encountered in hand dug test pits and visible in exposures generally consist of layered sand and silt. The nearly vertical cut at the crest of the slope is primarily comprised of silt, held in place by capillary tension. The steep slopes can be destabilized where they are subjected to surface water, seepage or a rise in groundwater, or where they are undermined by erosion or excavation. There are signs that flowing water has eroded the slope where it is concentrated on the skid trail and on recreational vehicle trails. Trees near the slope crest frequently have a buildup of mineral soil against the upslope face of tree trunks, indicating downslope soil migration. Aerial photos dated between 1993 and 2018 show the slope shape has not significantly changed over that period.
