GEONORTH ENGINEERING LTD.

January 29, 2020

Re: Geotechnical Assessment, 4244 Foothills Boulevard, Prince George, B.C.

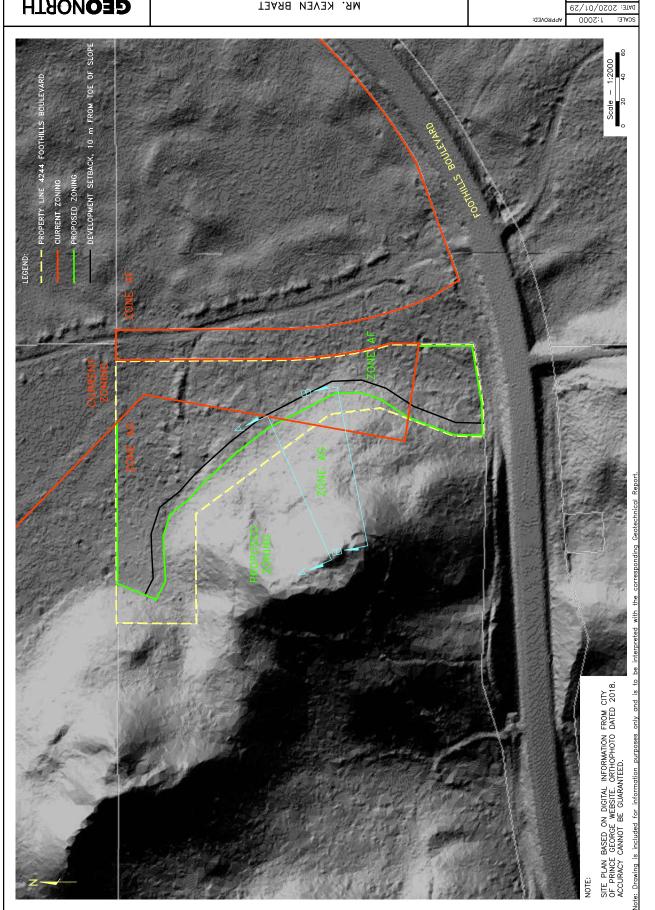
MR. KEVEN BRAET GEOTECHNICAL ASSESSMENT 4244 FOOTHILLS BOULEVARD, PRINCE GEORGE, B.C. SITE PLAN SHOWING LIDAR DATA

Contour maps show terrain below the east part of the property is relatively flat, between elevations 662 and 665 m. The west part of the property is located partly over the toe of a conical shaped hill, a kame, with moderate to steep gradients that extends up to elevation 722 m. The slope is 100 m long, has a concave profile and shows no signs of sliding. The lower part of the slope has moderate gradients between 35 and 50%, the mid part of the slope has moderately steep to steep gradients between 50 and 70%, and the top part of the slope is steep with gradients over 75%. A skid trail circles the hill and accesses a flat pad constructed at the top of the slope. The trail was constructed by excavating and side casting fill over the natural slope, resulting in a nearly vertical 3 m high pitch at the top of the slope. Behind the slope crest, the ground slopes west, away from the project area at a gentle gradient. A hillshade image is shown on Drawing 5302-A2, attached.

The transition in zoning between AG and AF at the time of writing does not follow a property line, a drainage, or terrain feature and seems to be arbitrary. From a geotechnical perspective, we recommend revising the zone boundary to that shown on Drawing 5302-A2.

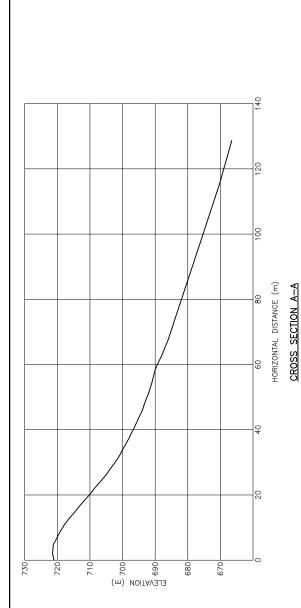
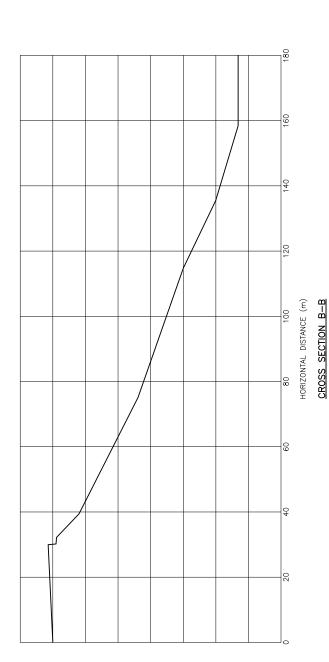
K-5302 РROJECT NO: 5A-2053 MR. KEVEN BRAET GEOTECHNICAL ASSESSMENT CROSS SECTIONS CROSS SECTIONS KENIZION: :ON SNIMARIO REVIEWED BY: WUL DRAWN BY: DATE: 2020/01/29 SCALE: 1:750 APPROVED:

Cross sections from hip-chain and clinometer readings taken during the site assessment and from ground contour information from the City of Prince George website are shown on Drawing 5302-A3, attached.
