# PRP HOLDINGS LTD.

GEOTECHNICAL ASSESSMENT:  
CONDO DEVELOPMENT AT  
1177 FOOTHILLS BOULEVARD,

JULY 26, 2022  
REVISION 4

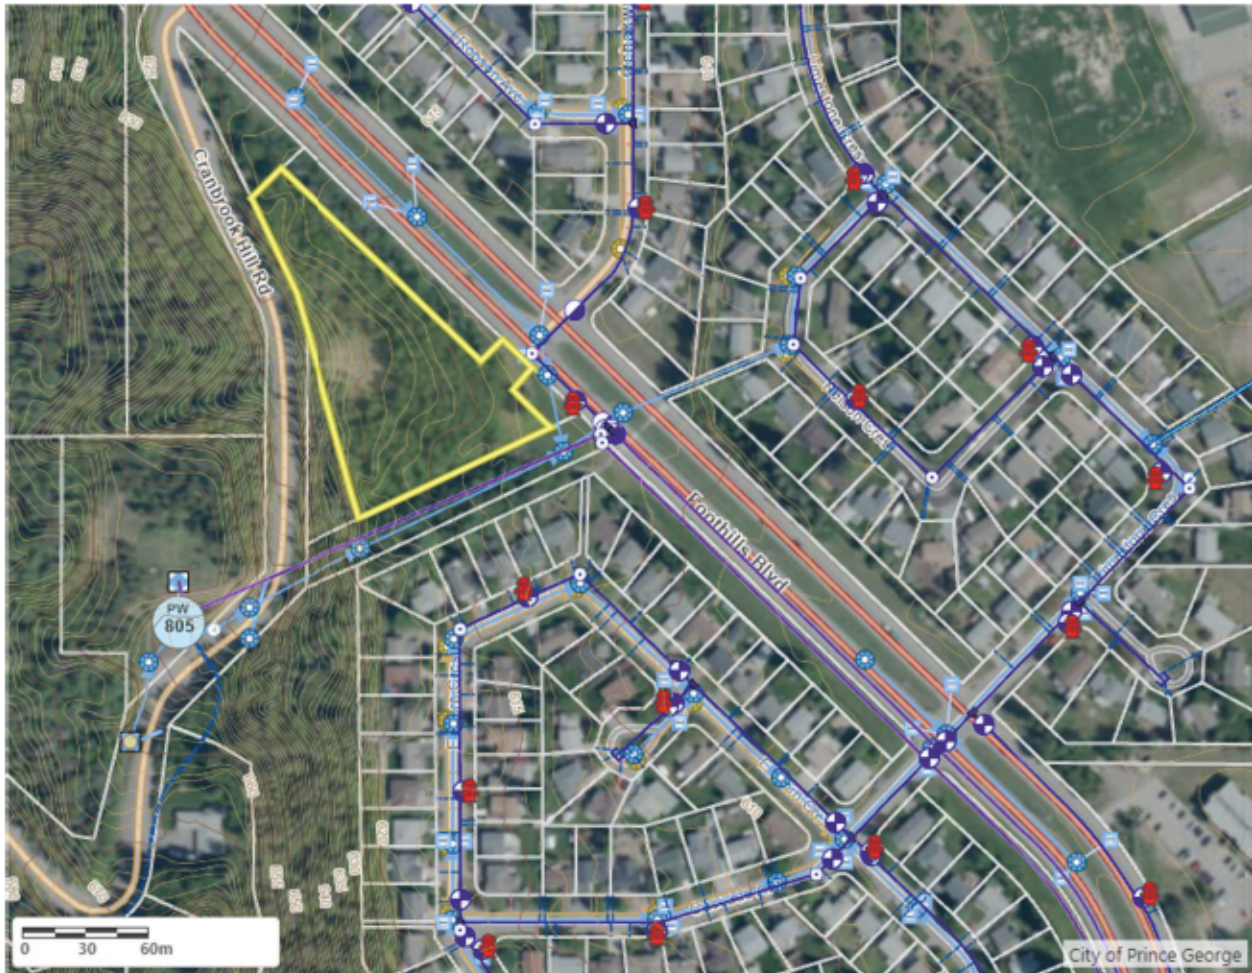
Figure 1. Project location and nearby City of Prince George infrastructure shown on PG Map 2020 Otho Imagery

From discussions with PRP and a review for preliminary drawings we understand the development will consist of a six (6) storey building with an elevator and a parkade. The building will be located near the northwest property line and be supported on conventional concrete foundations with grade supported floor slabs. The lot is located at the toe of Cranbrook Hill below Cranbrook Hill Road. The slope is approximately 28 m in height, has an average grade of approximately 33%, and lies to the west of the proposed condo location. The Cranbrook Hill Reservoir PW 805 lie above and to the west of the property. PW 805 connects to the watermain buried in Foothills Boulevard via a buried line running parallel to the southern property line as shown in Figure 1.

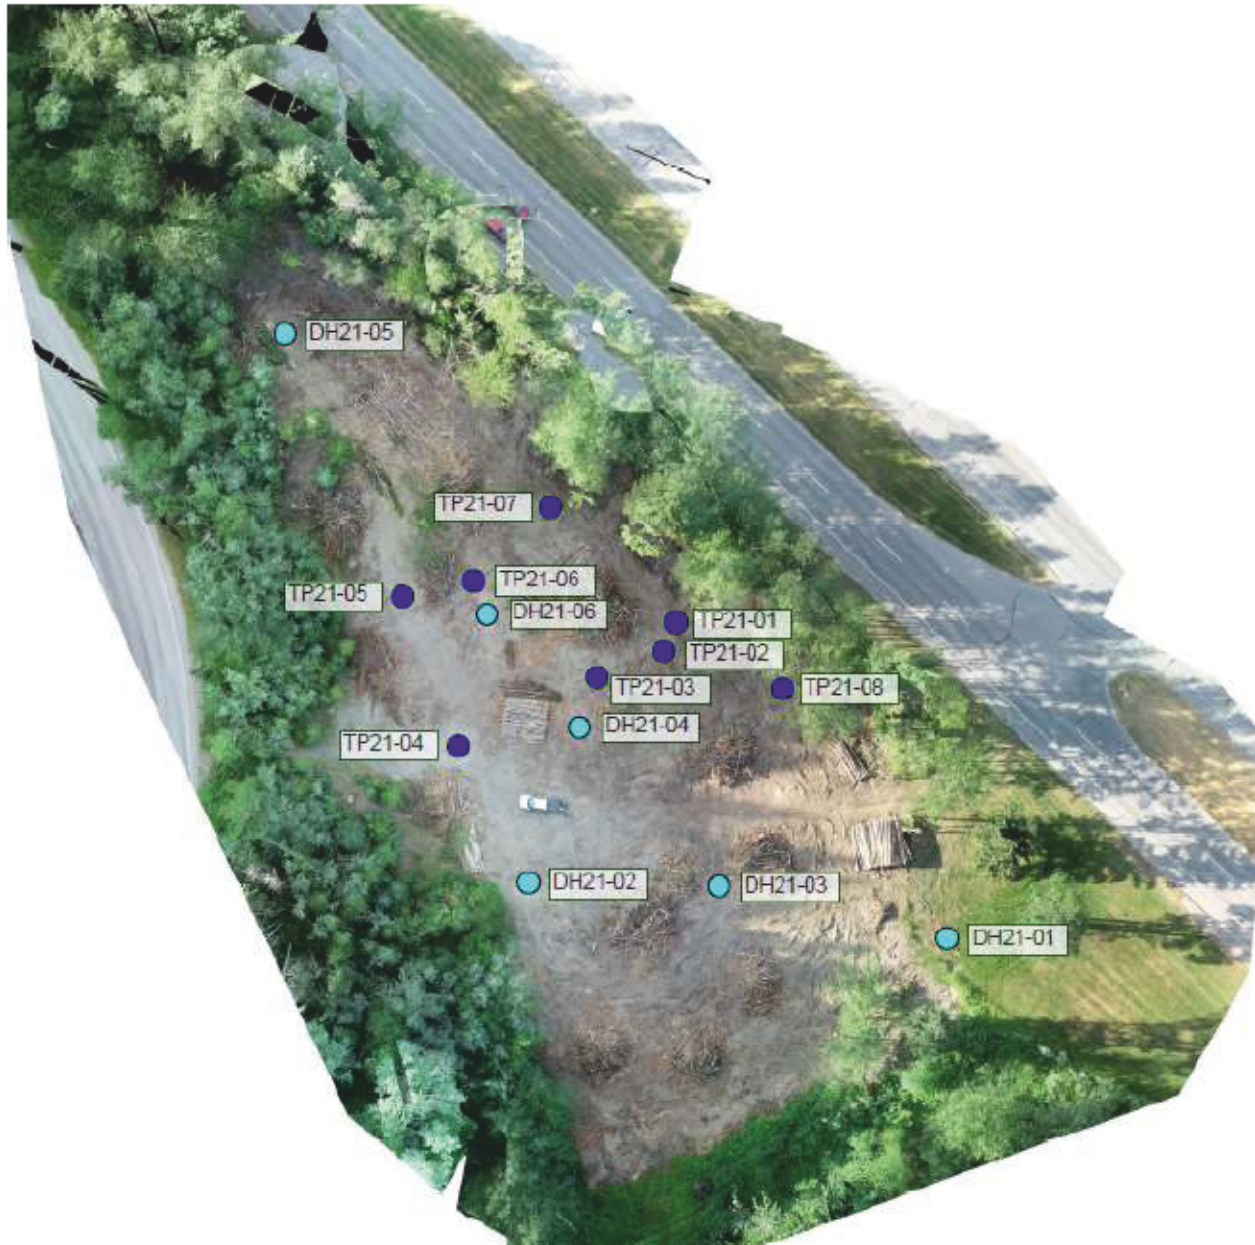
Figure 2. Proposed Development area and investigation locations. Orthophoto created on June 20, 2021.

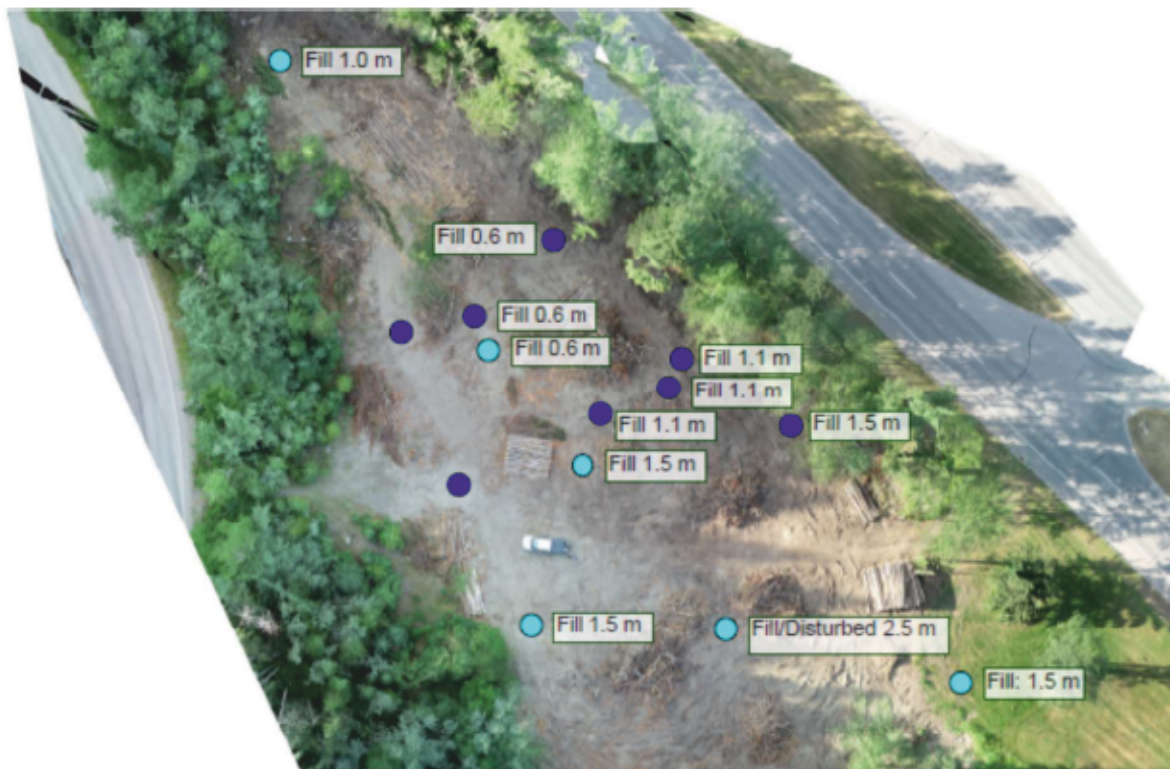
Figure 3. Test pits and drill hole locations where fill was encountered and depth to natural soil.

Undocumented fill or disturbed material was encountered in most of the drill holes and the test pits except TP21-04 & TP 21-05. The fill generally consisted of very loose sand with some gravel and trace fines. The fill we observed was generally free of organics and deleterious materials. The locations of test pits and drill holes encountering undocumented fill and the depth at those location where natural soil was observed is presented in Figure 3.

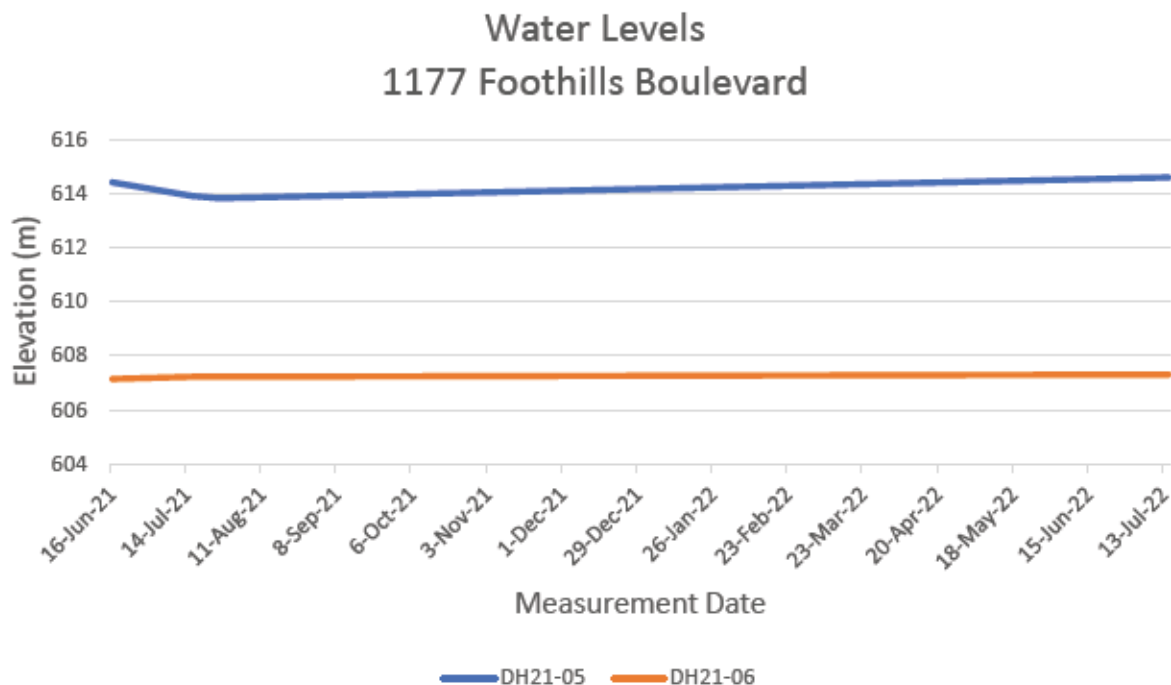
Figure 4. Measured groundwater levels

Groundwater monitoring wells were installed in DH21-05 and DH21-06. The wells were monitored between June 16, 2021 and July 15, 2022. The water levels detailed in Figure 5 show minimal fluctuation. We will continue to monitor the levels at the site up into and including the construction period of the building and will provide updated recommendations if it is determined the groundwater will influence bearing support.

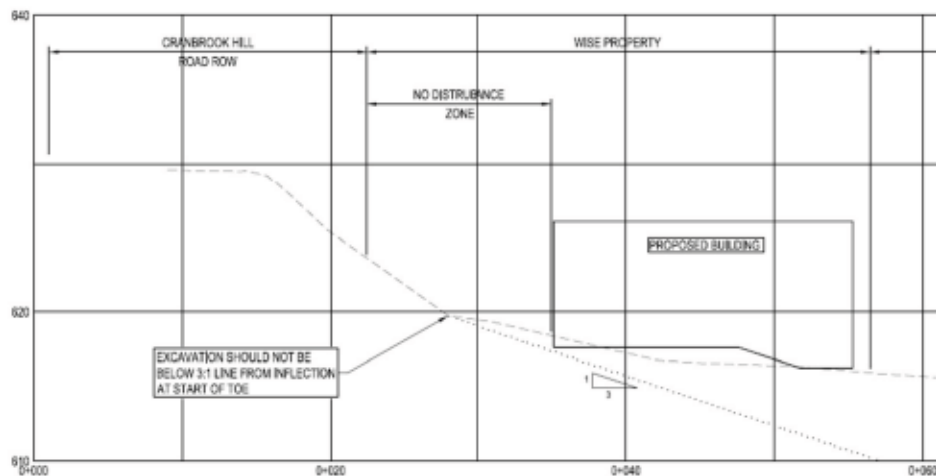
Figure 6. Example of excavation depth limitation shown on McElhanney Drawing SK02

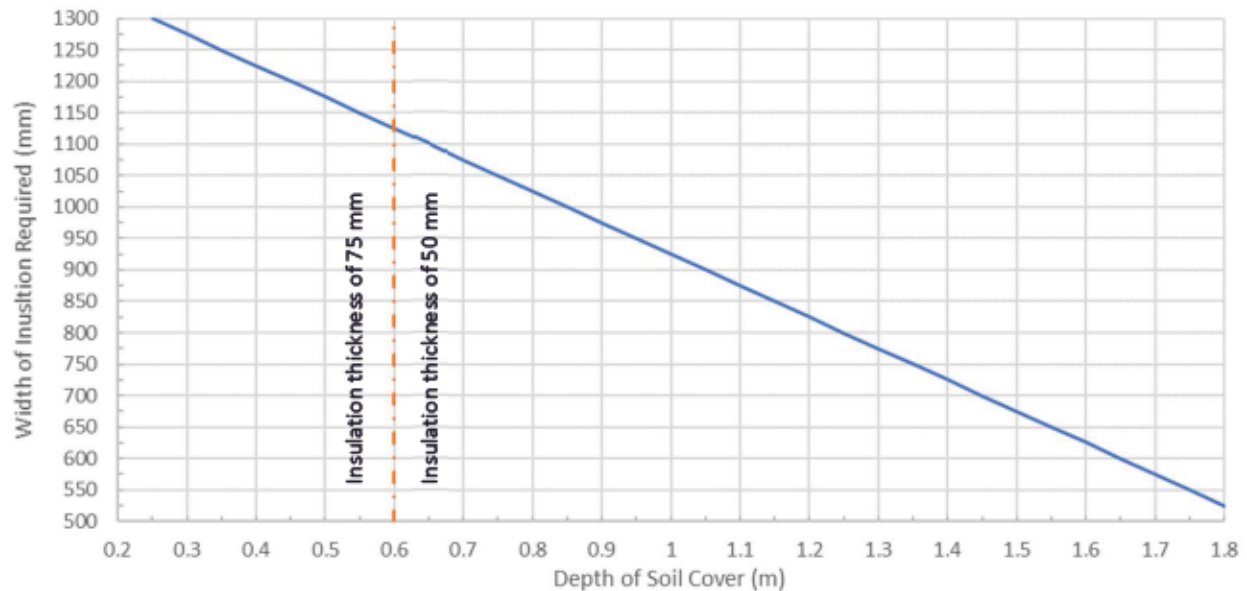
Figure 5. Insulation thickness and width required based on installation depth.

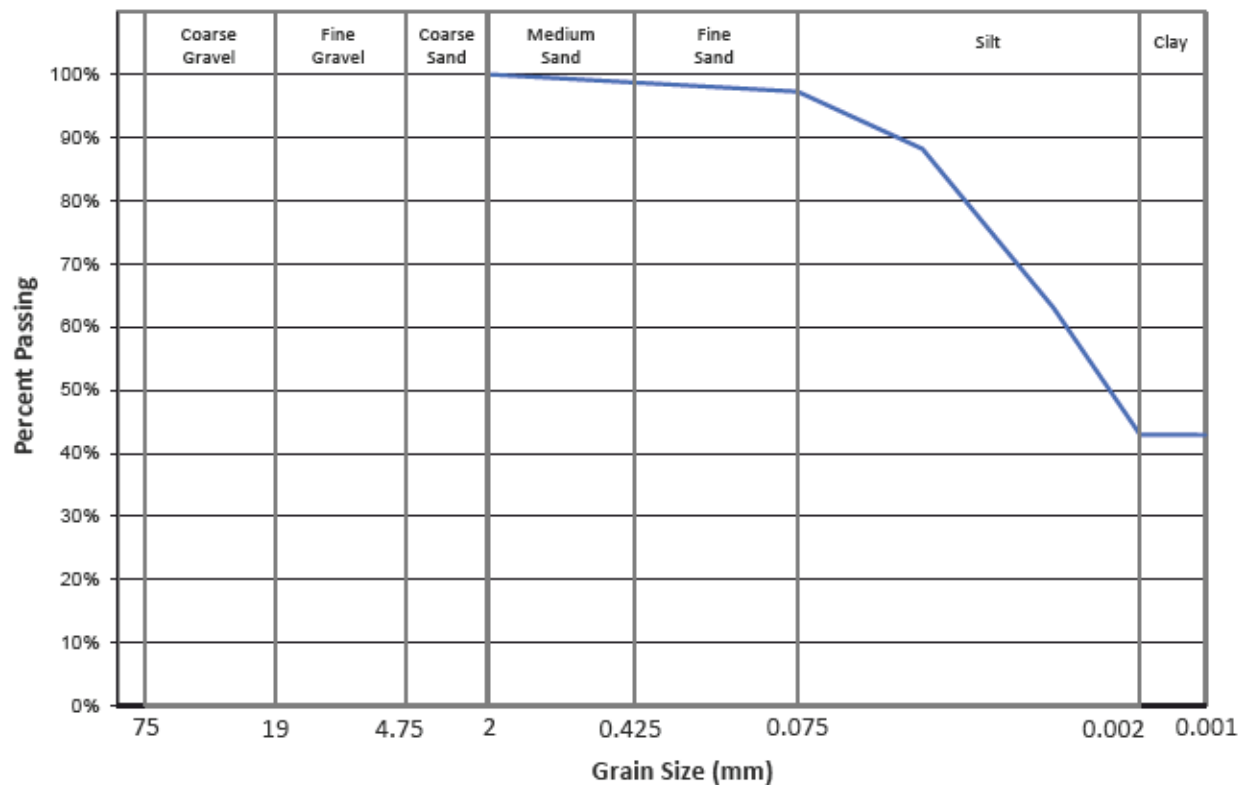
Source	DH21-03	Sampling Date	June 14, 2021
Sample ID	B03-5	Date Tested	June 21, 2021
Depth	20-21.75 ft	Sampled By	P. Nielsen
Description	Silt and Clay, trace Sand	Tested By	P.Nielsen
Moisture Content	31.7%

Gravel	0.0%	Sand	2.7%	Silt	54.4%	Clay	42.9%
--------	------	------	------	------	-------	------	-------

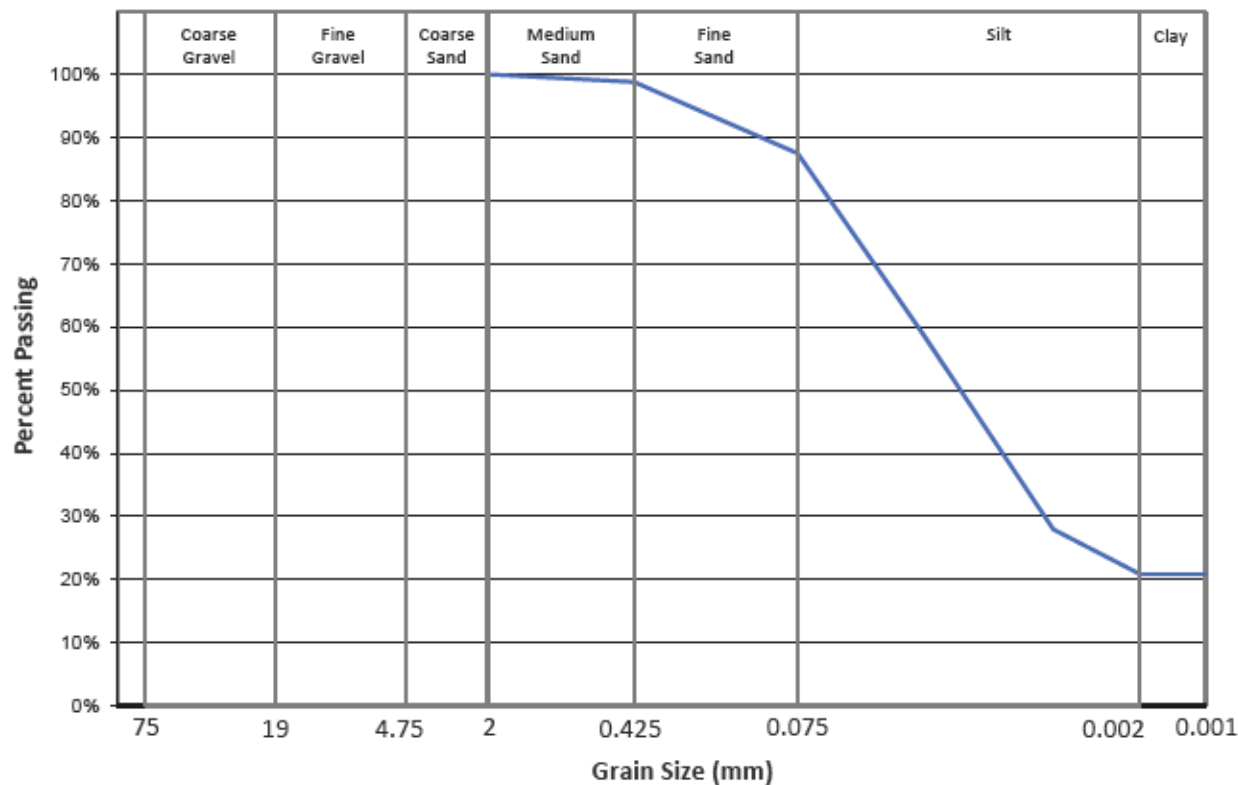
Source	DH21-01	Sampling Date	June 14, 2021
Sample ID	B01-2	Date Tested	June 21, 2021
Depth	6-7 ft	Sampled By	P. Nielsen
Description	SILT, Clayey, some sand	Tested By	P.Nielsen
Moisture Content	25.6%

Gravel	0.0%	Sand	12.5%	Silt	66.7%	Clay	20.8%
--------	------	------	-------	------	-------	------	-------

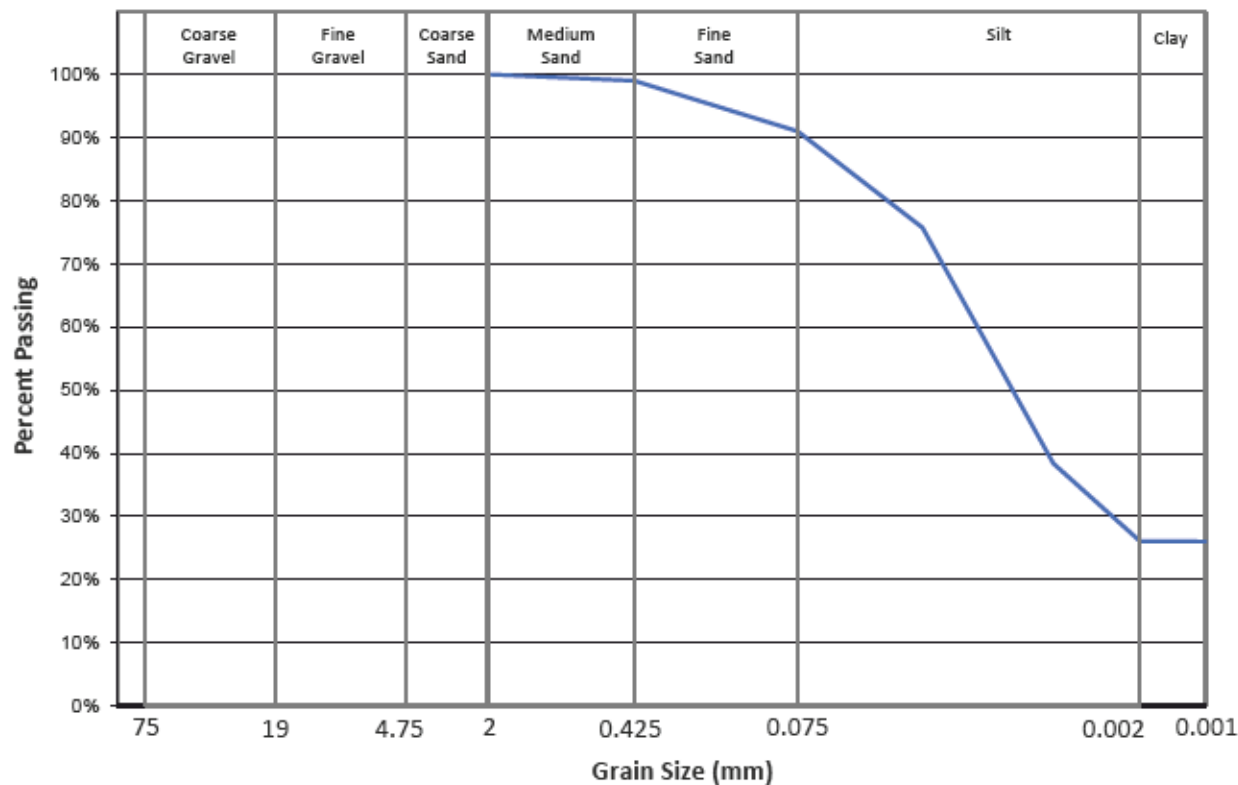
Source	TP21-08	Sampling Date	June 16, 2021
Sample ID	B08-1	Date Tested	June 21, 2021
Depth	1.6 m	Sampled By	P. Nielsen
Description	SILT, Clayey, trace Sand	Tested By	P.Nielsen
Moisture Content	23.5%

Gravel	0.0%	Sand	9.0%	Silt	65.0%	Clay	26.0%
--------	------	------	------	------	-------	------	-------

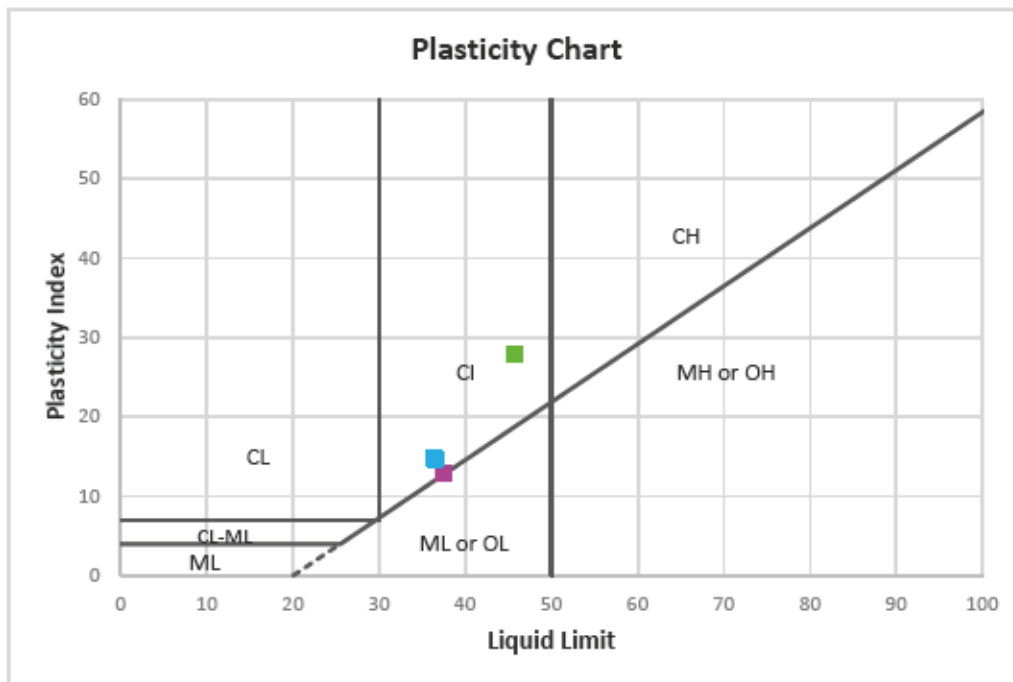
Symbol	Sample ID	Location	Depth	Passing 425 $\mu$ m (%)	Natural Moisture (%)	Liquid Limit	Plastic Limit	Plasticity Index	Soil Type
■	B01-2	DH 21-01	6-7 ft	90	25.6	46	18	28	CI
■	B03-5	DH21-03	20-21.75 ft	97.6	31.7	38	25	13	CI
■	B08-1	TP21-08	1.6 m	87.6	23.5	37	22	15	CI

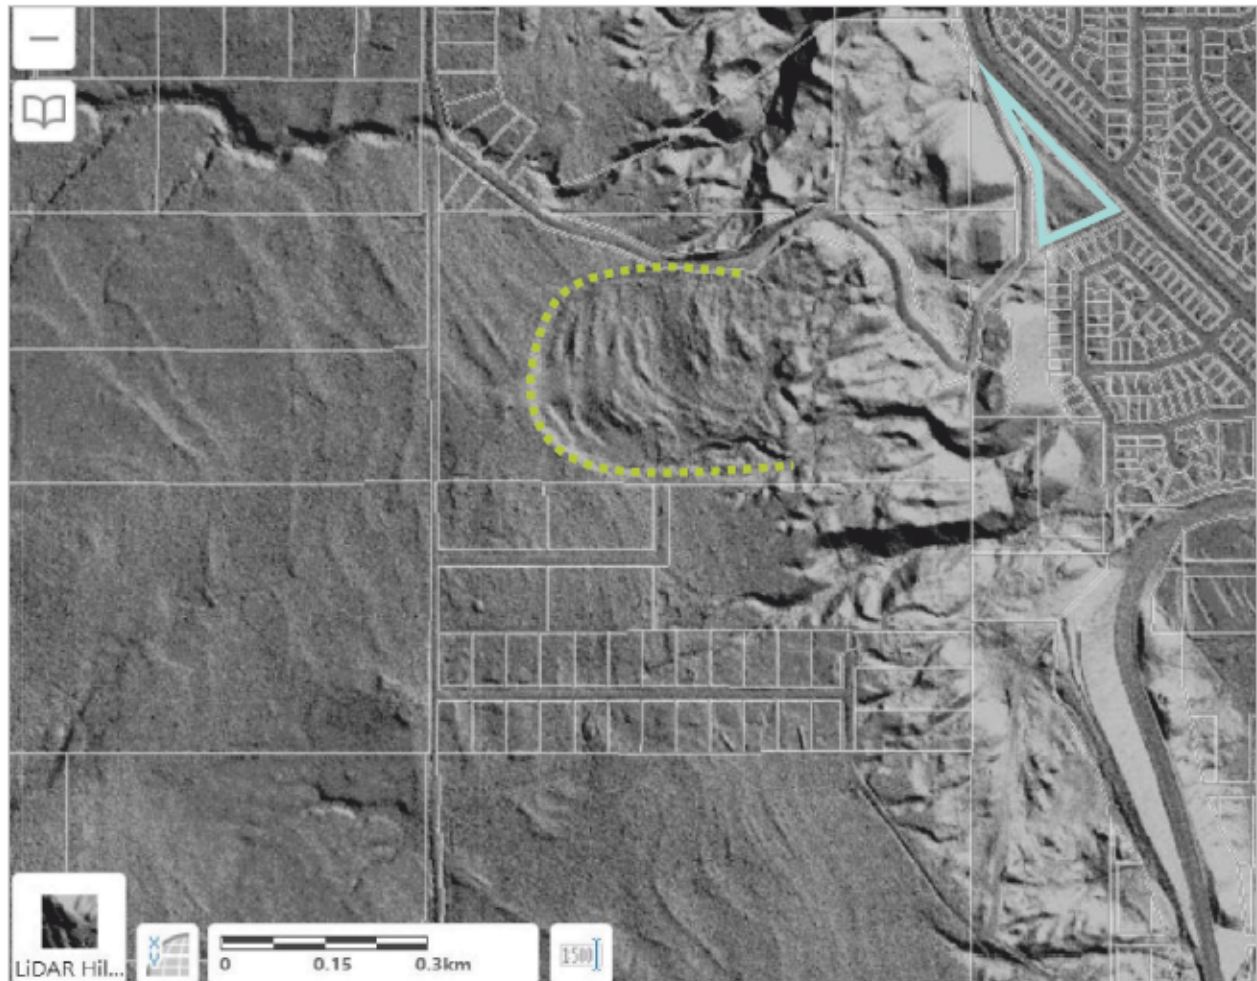
*Figure 2. Hummocky land with a curved headscarp is likely a landslide, although age and rate of movement is not known. Yellow outlines the likely landslide headscarp, and light blue outlines the site (Image source: PGMap, <https://pgmappub.princegeorge.ca>).*

There is a presumed medium-sized landslide south of Cranbrook Hill Road visible in CoPG LiDAR that has been zoned as “Community Forest” southwest (upslope) of the site (see [Figure 2](#)).

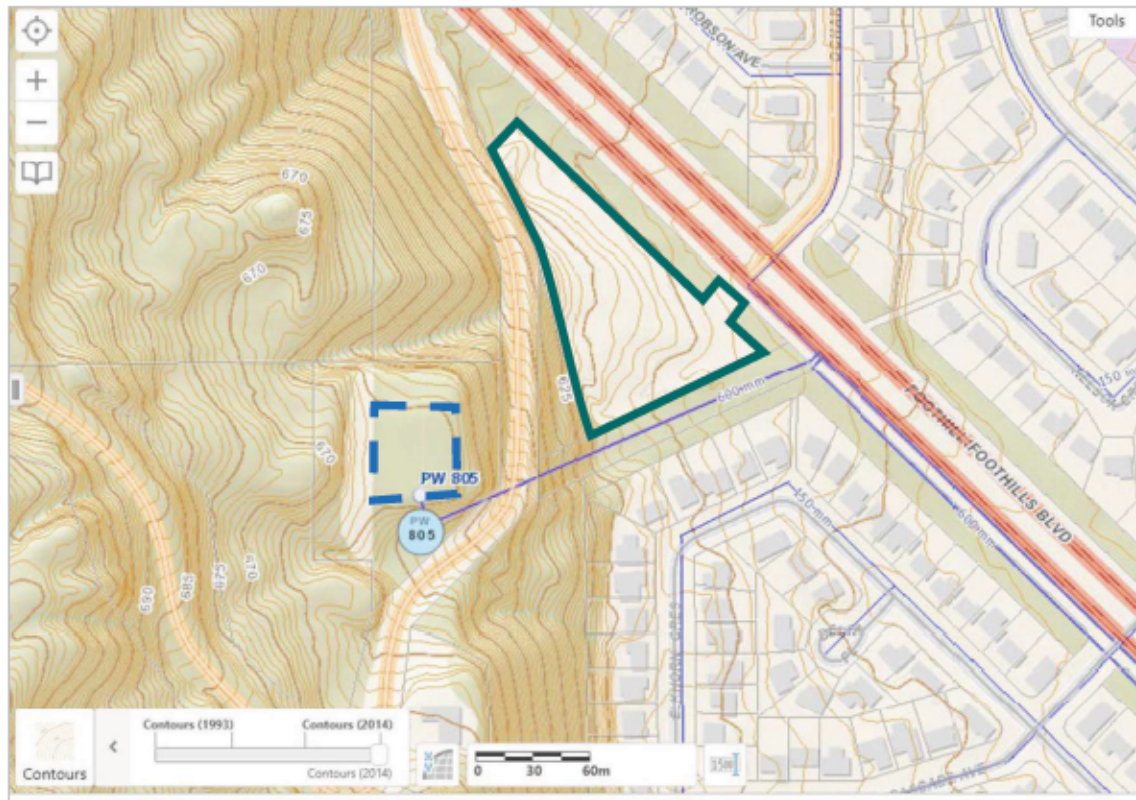
Figure 3: Local water infrastructure in relation to the site. Pumping well and reservoir located approximately in dashed blue outline, site outline in dark teal (Image source: PGMap, <https://pgmappub.princegeorge.ca>).

could leak, which increases the destabilizing effects of water pressure beyond any background/natural groundwater or seepage that could be present in the area. In addition, it is assumed, due to the age of the infrastructure, that both the reservoir and Cranbrook Hill Road are constructed with undocumented fills.

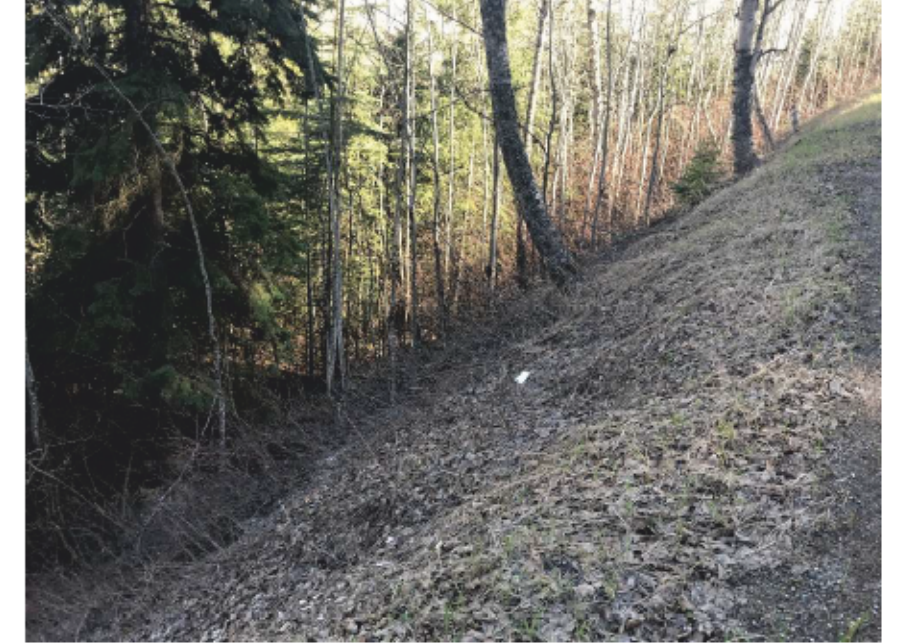
**PHOTOGRAPH NO. 3:** Pistol-butted trees near middle (Cross section B) of the slope.

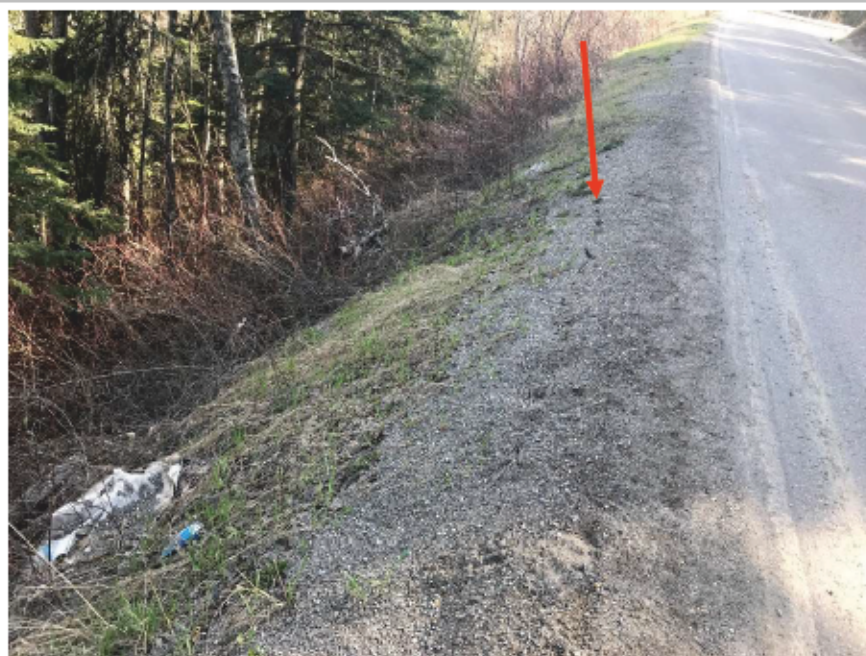
**PHOTOGRAPH NO. 4:** Cracking in shoulder at crest of slope (at arrow) between cross sections B and C.
