# Comments on Planning and Land Use Applications

RZ100763 - Bylaw 9348 (Dawson Road (PID: 015-258-360) - Meeting Date: March 13, 2023

Please find attached a letter containing my concerns and a copy of the 2011 Triton Environmental/Drainage assessment.

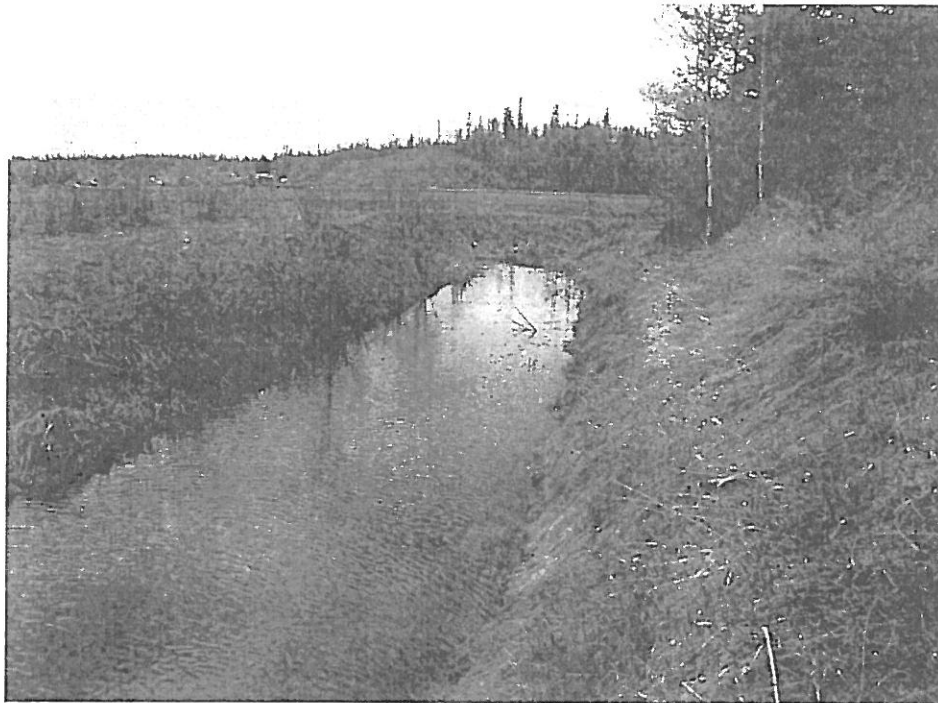
**Plate 1.** Drainage 1, reach 1: Upstream view. The 10 m wet width is exaggerated due to the ditching and ponding. Riparian vegetation is lacking along the right bank throughout.

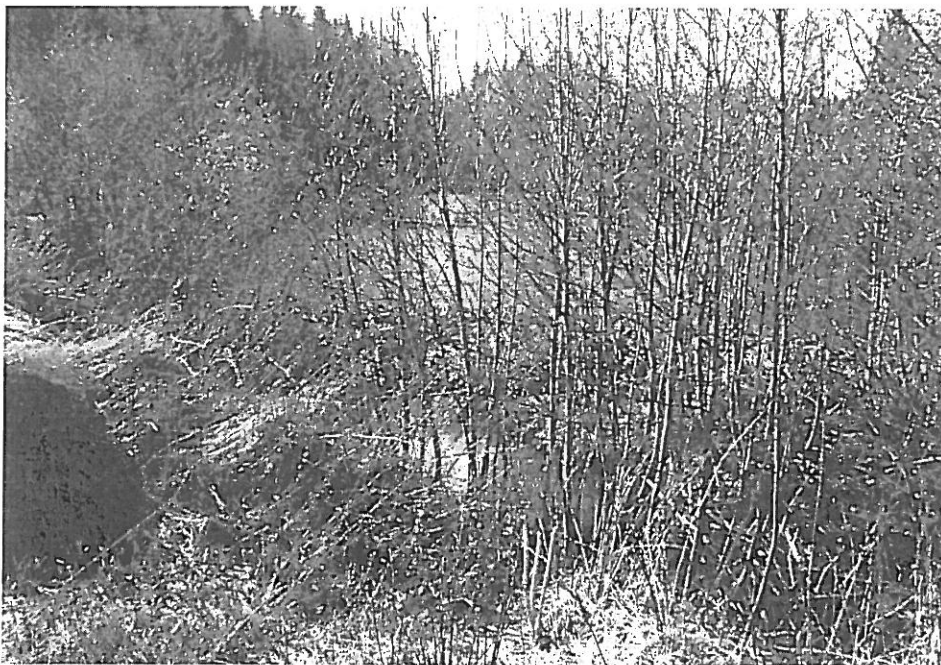
**Plate 2.** Tributary A, reach 1: Upstream view from above backwatered culvert inlet. Wide beaver pond in broad ravine upstream of the road grade.

Two mapped drainages (PGMAP 2011) were encountered in reach 1. The first (Tributary A) is connected through a backwatered CMP crossing of a dirt road grade. A beaver dam complex was observed immediately upstream of the culvert inlet which creates a 2 ha beaver pond that has flooded the broad (>150 m wide) steep sided ravine to a depth exceeding 1 m (Plate 2). The second (Tributary B) consists of a roadside drainage ditch which lacks a defined channel and possesses an NCD classification (Plate 3; see attached non-fish bearing status report). This ditch is confined by the road grade and adjacent steep vegetated slope.

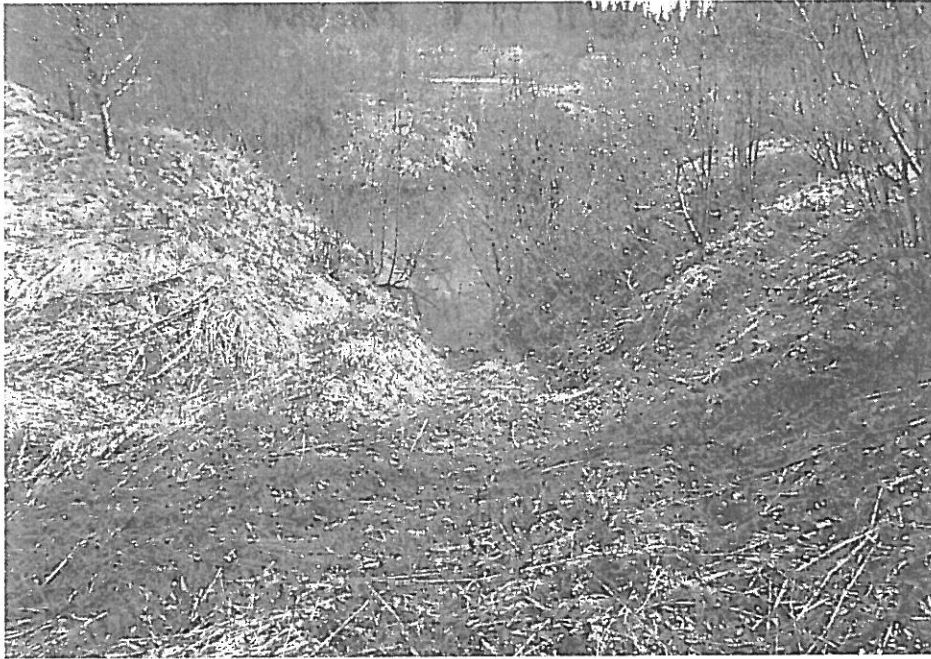
**Plate 3.** Tributary B, reach 1: View down ditchline toward main channel of drainage 1. An ATV ford descends the grassy slope at >30% down the embankment which forms a barrier.

**Comments:** No fish habitat present within ditch. No channel or scour was observed suggesting flows are infrequent and inadequate to provide perennial habitat. ATV's have forded Birchwood Creek in this location which has impacted the natural drainage pattern (Plate 3).

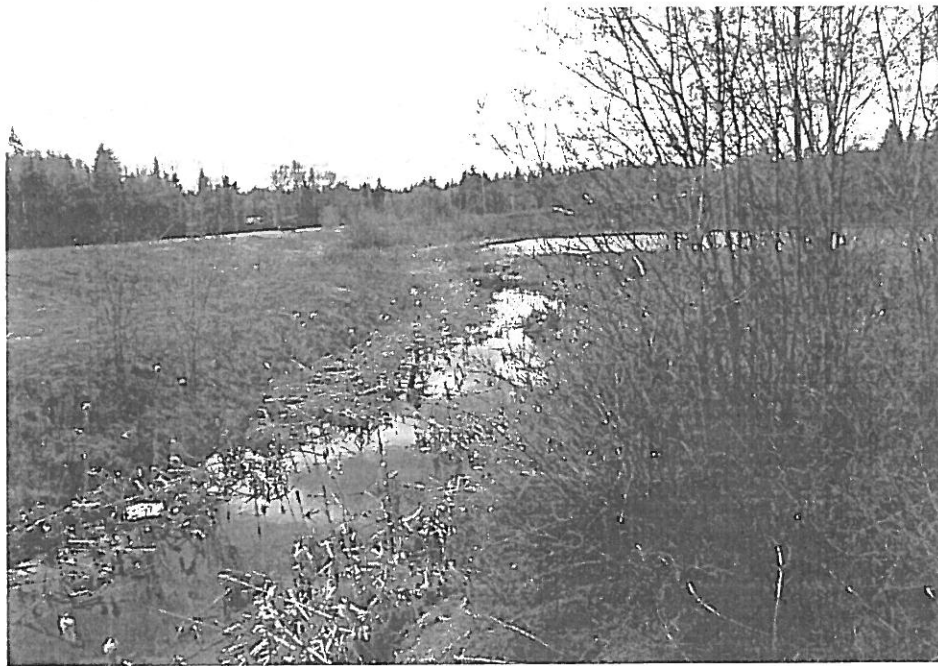
**Plate 4.** Drainage 1, reach 2: View upstream, channel narrows toward Birchwood Lake (~3 ha). Dense cattail surrounds the wetted perimeter of this feature which is greater than 2 m deep.

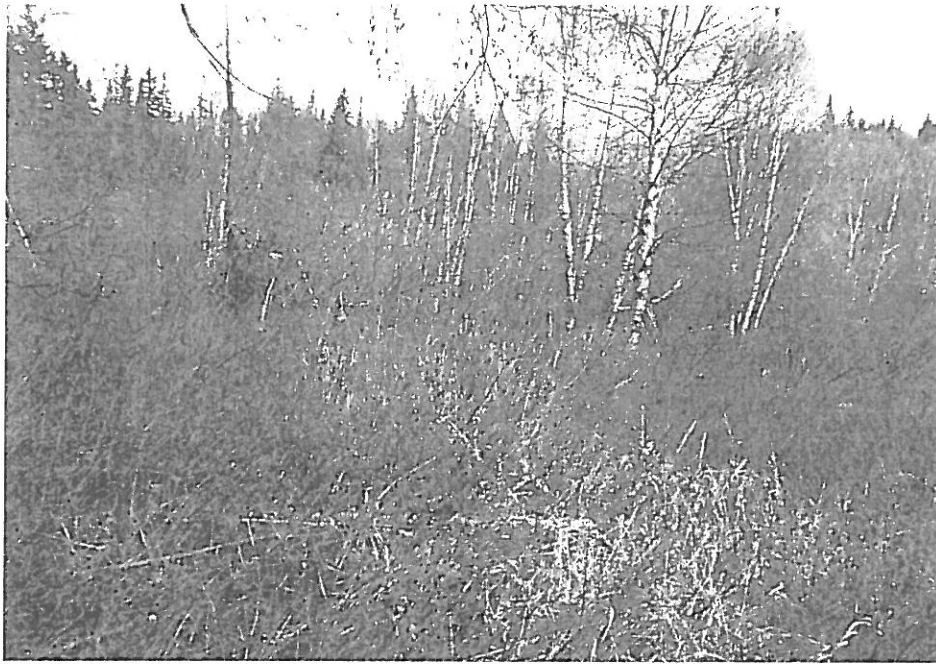
**Plate 5.** Tributary C, reach 1: View up drainage. A NCD classification based on no defined channel and subsurface flows through thick vegetation rooted in 100% organic soils.

**Comments:** No fish habitat present within this seasonal drainage. No channel or scour was observed suggesting flows are seasonal and inadequate to provide perennial habitat. Reach 1 and 2 possess an NCD classification (Plates 5 and 6). Reach 3 consists of an ephemeral pond less than 0.5 m deep which supplies the drainage seasonally (Plate 7).

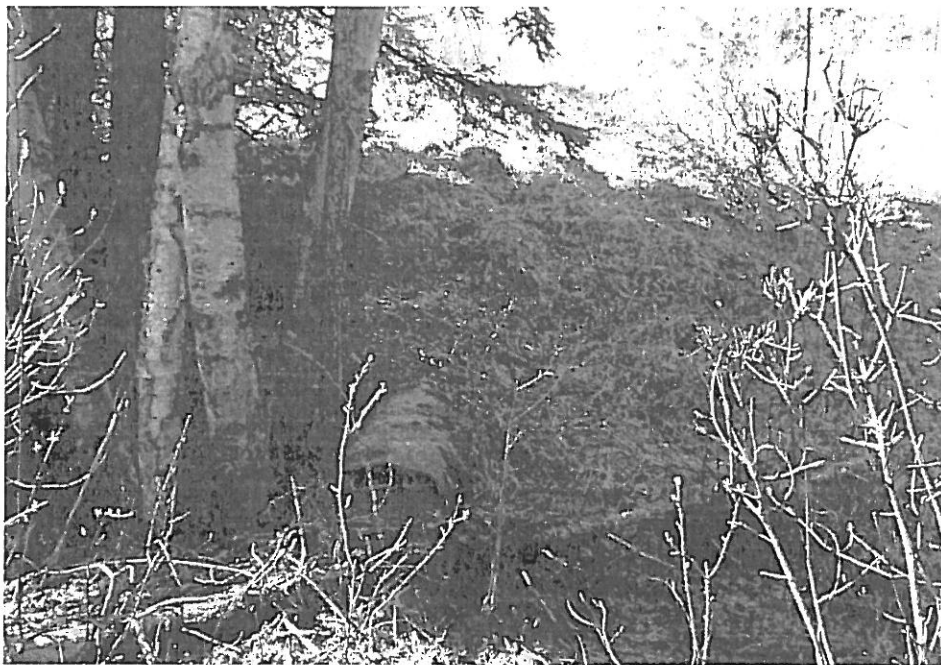
**Plate 6.** Tributary C, reach 2: View up drainage toward collapsed and plugged steel culvert. A NCD classification based on no defined channel. This seasonal drainage has a gradient exceeding 15% through this reach with embankment slopes exceeding 33%.

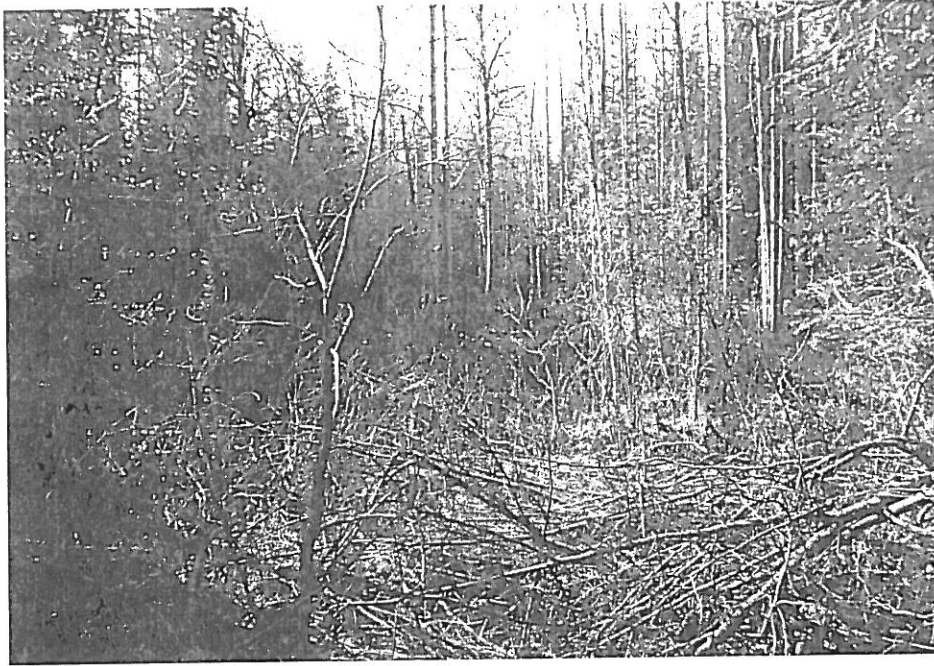
**Plate 7.** Tributary C, reach 3: Small (0.06 ha) ephemeral pond represents the terminal reach of this seasonal drainage. Thick rooted vegetation occupies the drainage basin with side slopes exceeding 20%. A NCD wetland classification is considered appropriate.

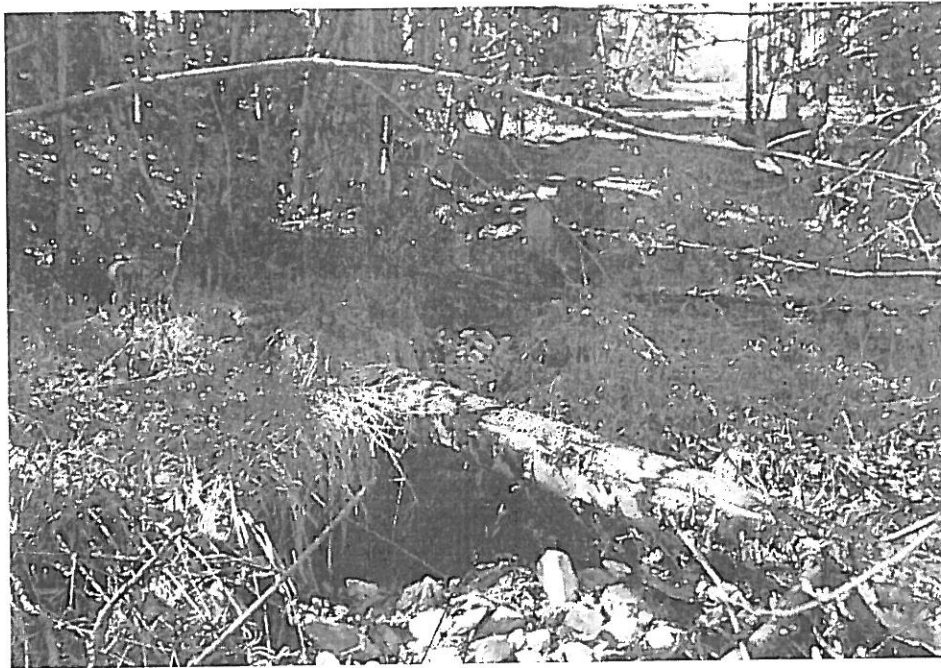
**Plate 8.** Tributary D, reach 1: Riprap controlled pools at outlet of storm drain pipe which forms a barrier approximately 44 m upstream of Birchwood Lake.

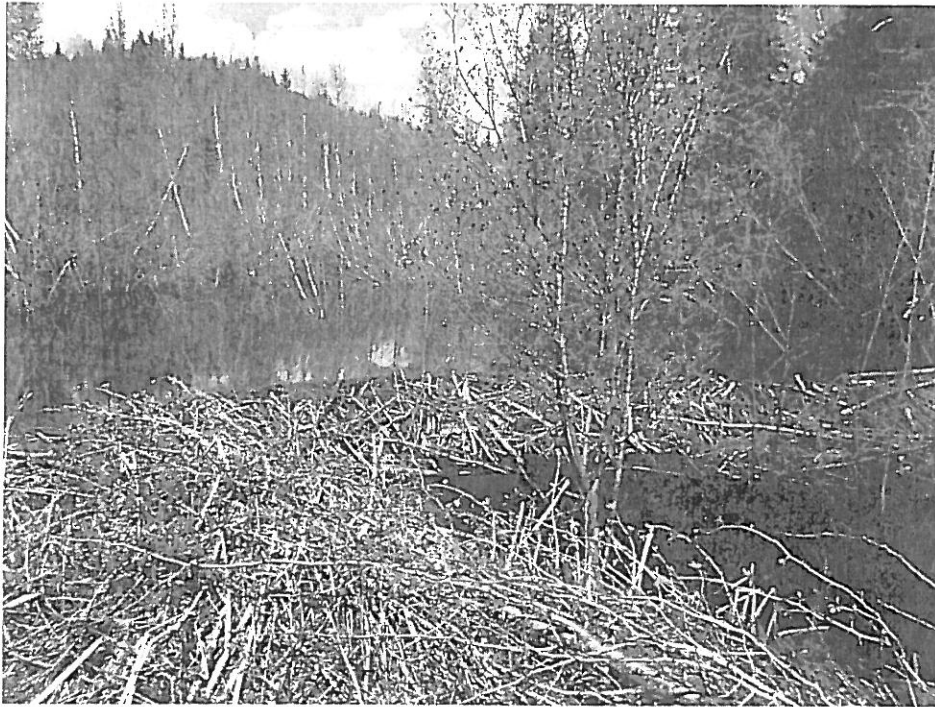
**Plate 9.** Drainage 2, reach 1: Lower end of Beaver Pond (~1 ha). Dense alder and birch suggest the margins are seasonally flooded.

**Upstream / Downstream Fish:** No perennial fish habitat was observed within or upslope of reach 2, since no defined channel or evidence of surface flows were observed. A beaver pond in reach 1 forms the nearest potential fish rearing habitat (Plate 9). Minnow trapping failed to produce fish within this reach.

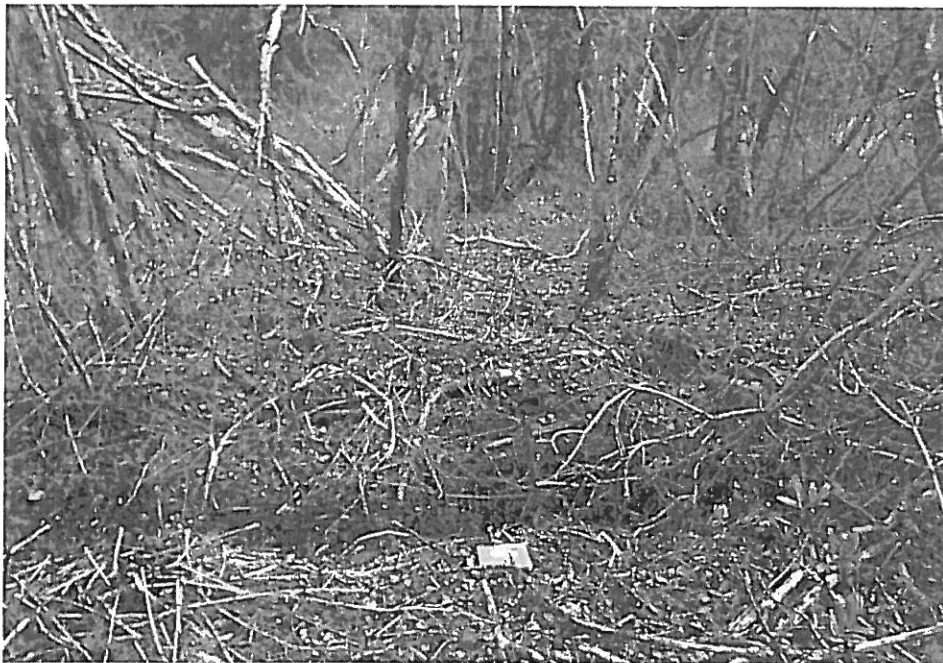
**Plate 10.** Drainage 2 reach 1 and 2: Cross section view shows gradient increase and loss of channel definition. Flows were subsurface of organic soils and perennial habitats are non-existent upstream of this location. As such, the drainage through reach 2 was classed as NCD.

Reach 2 is 180 m in length, lacks a defined channel and supports an NCD classification. The seasonal drainage possessed a consistent 3% gradient and occurs within a broad (>50 m wide) ravine. No defined channel was observable in the organic layer which dominated the ravine bottom, though subsurface flow is likely, however no perennial fish habitat was observed within or upslope of this reach (Plate 10; see attached non-fish bearing status report).

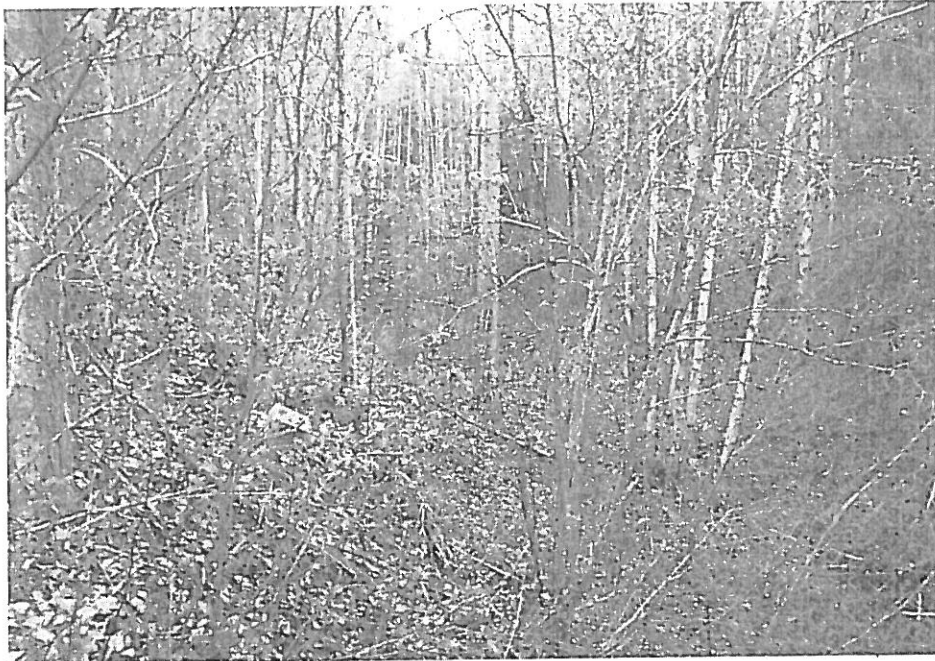
**Plate 11.** Drainage 2, reach 3: The gradient of this seasonal drainage ranges from 8-10% as it ascends the ravine. The entire drainage is NCD beyond this reach

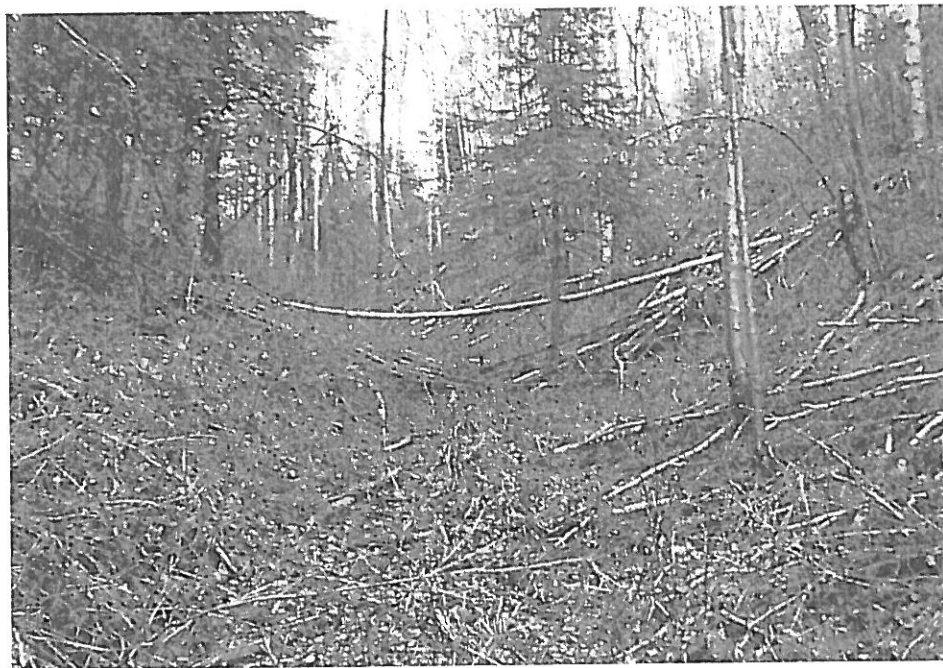
**Plate 12.** Drainage 2, reach 4: Overview of site. Ravine narrows, side slopes increase, and gradient increases to >15 %. No defined channel in this seasonal drainage.

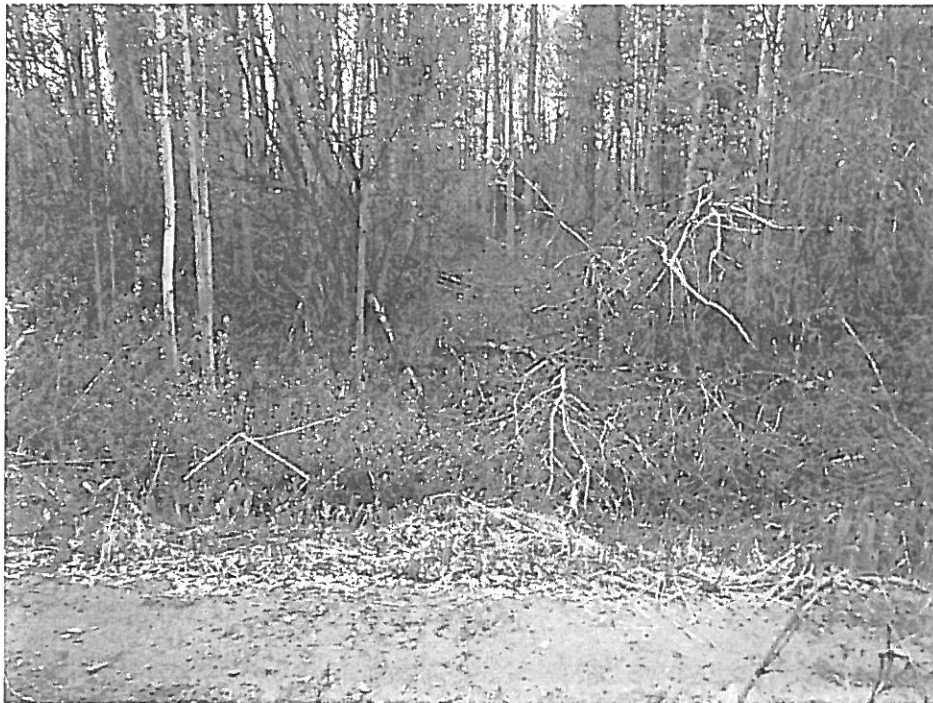
**Plate 13.** Drainage 2 reach 5: Overview of site. Ravine loses definition, side slopes decrease, and gradient eases to 5 % upslope of the road which lacks a drainage structure.

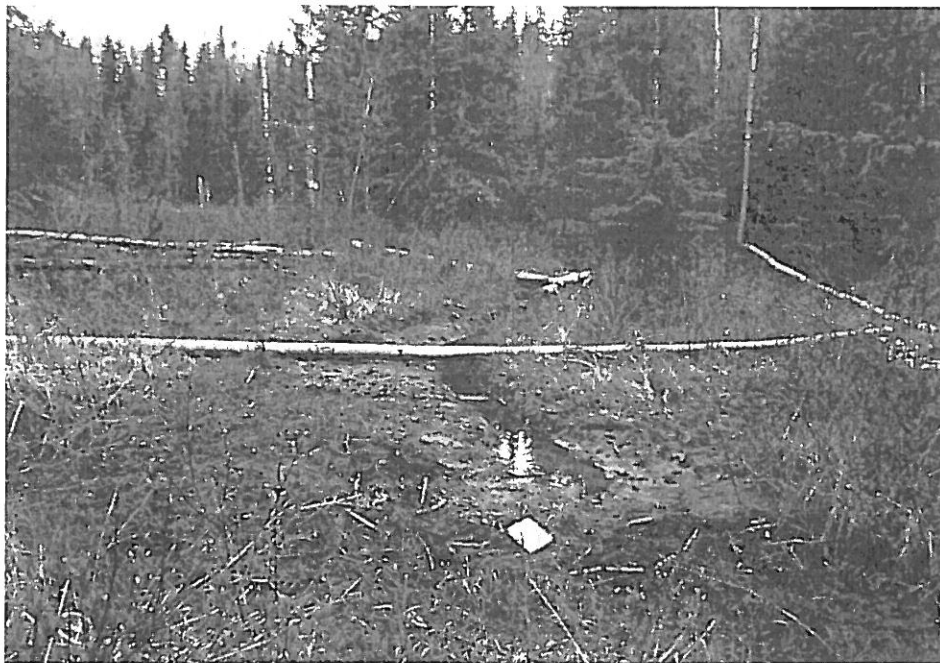
**Plate 14.** Tributary F, reach 3: Location where 0.6 m wide by 75 m long channel disappears as it flows subsurface into the organic substrates. No perennial habitat observed within this reach.

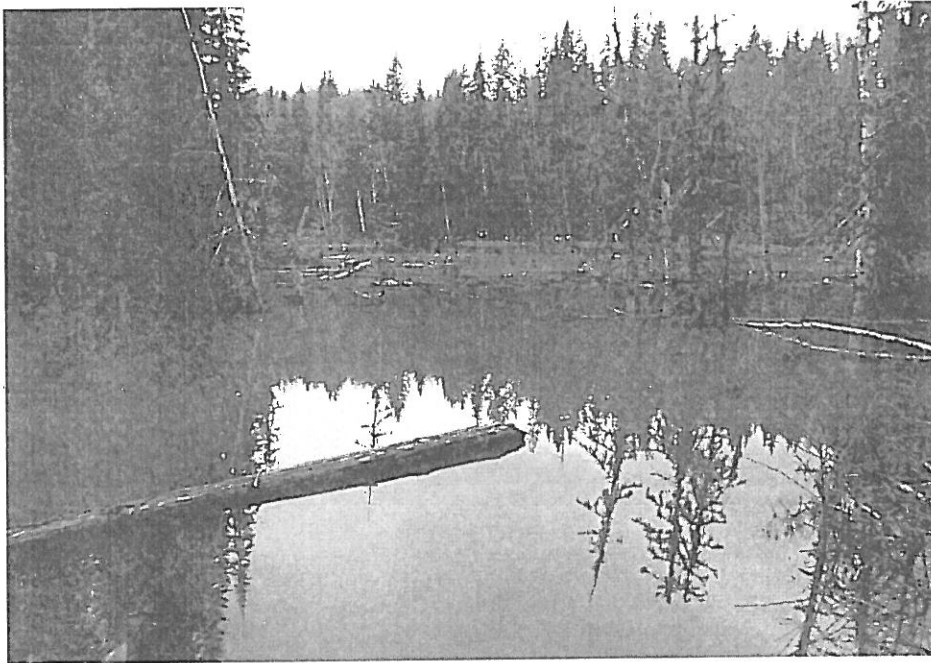
**Plate 15.** Tributary E, reach 4: Large beaver pond (~2 ha) confined to the steep walled ravine which is considered non-fish bearing, supplies groundwater recharge to the drainage, and forms a sediment sink for headwater drainages.
