January 29, 2020

File No. K-5302

**Re: Geotechnical Assessment,
4244 Foothills Boulevard, Prince George, B.C.**

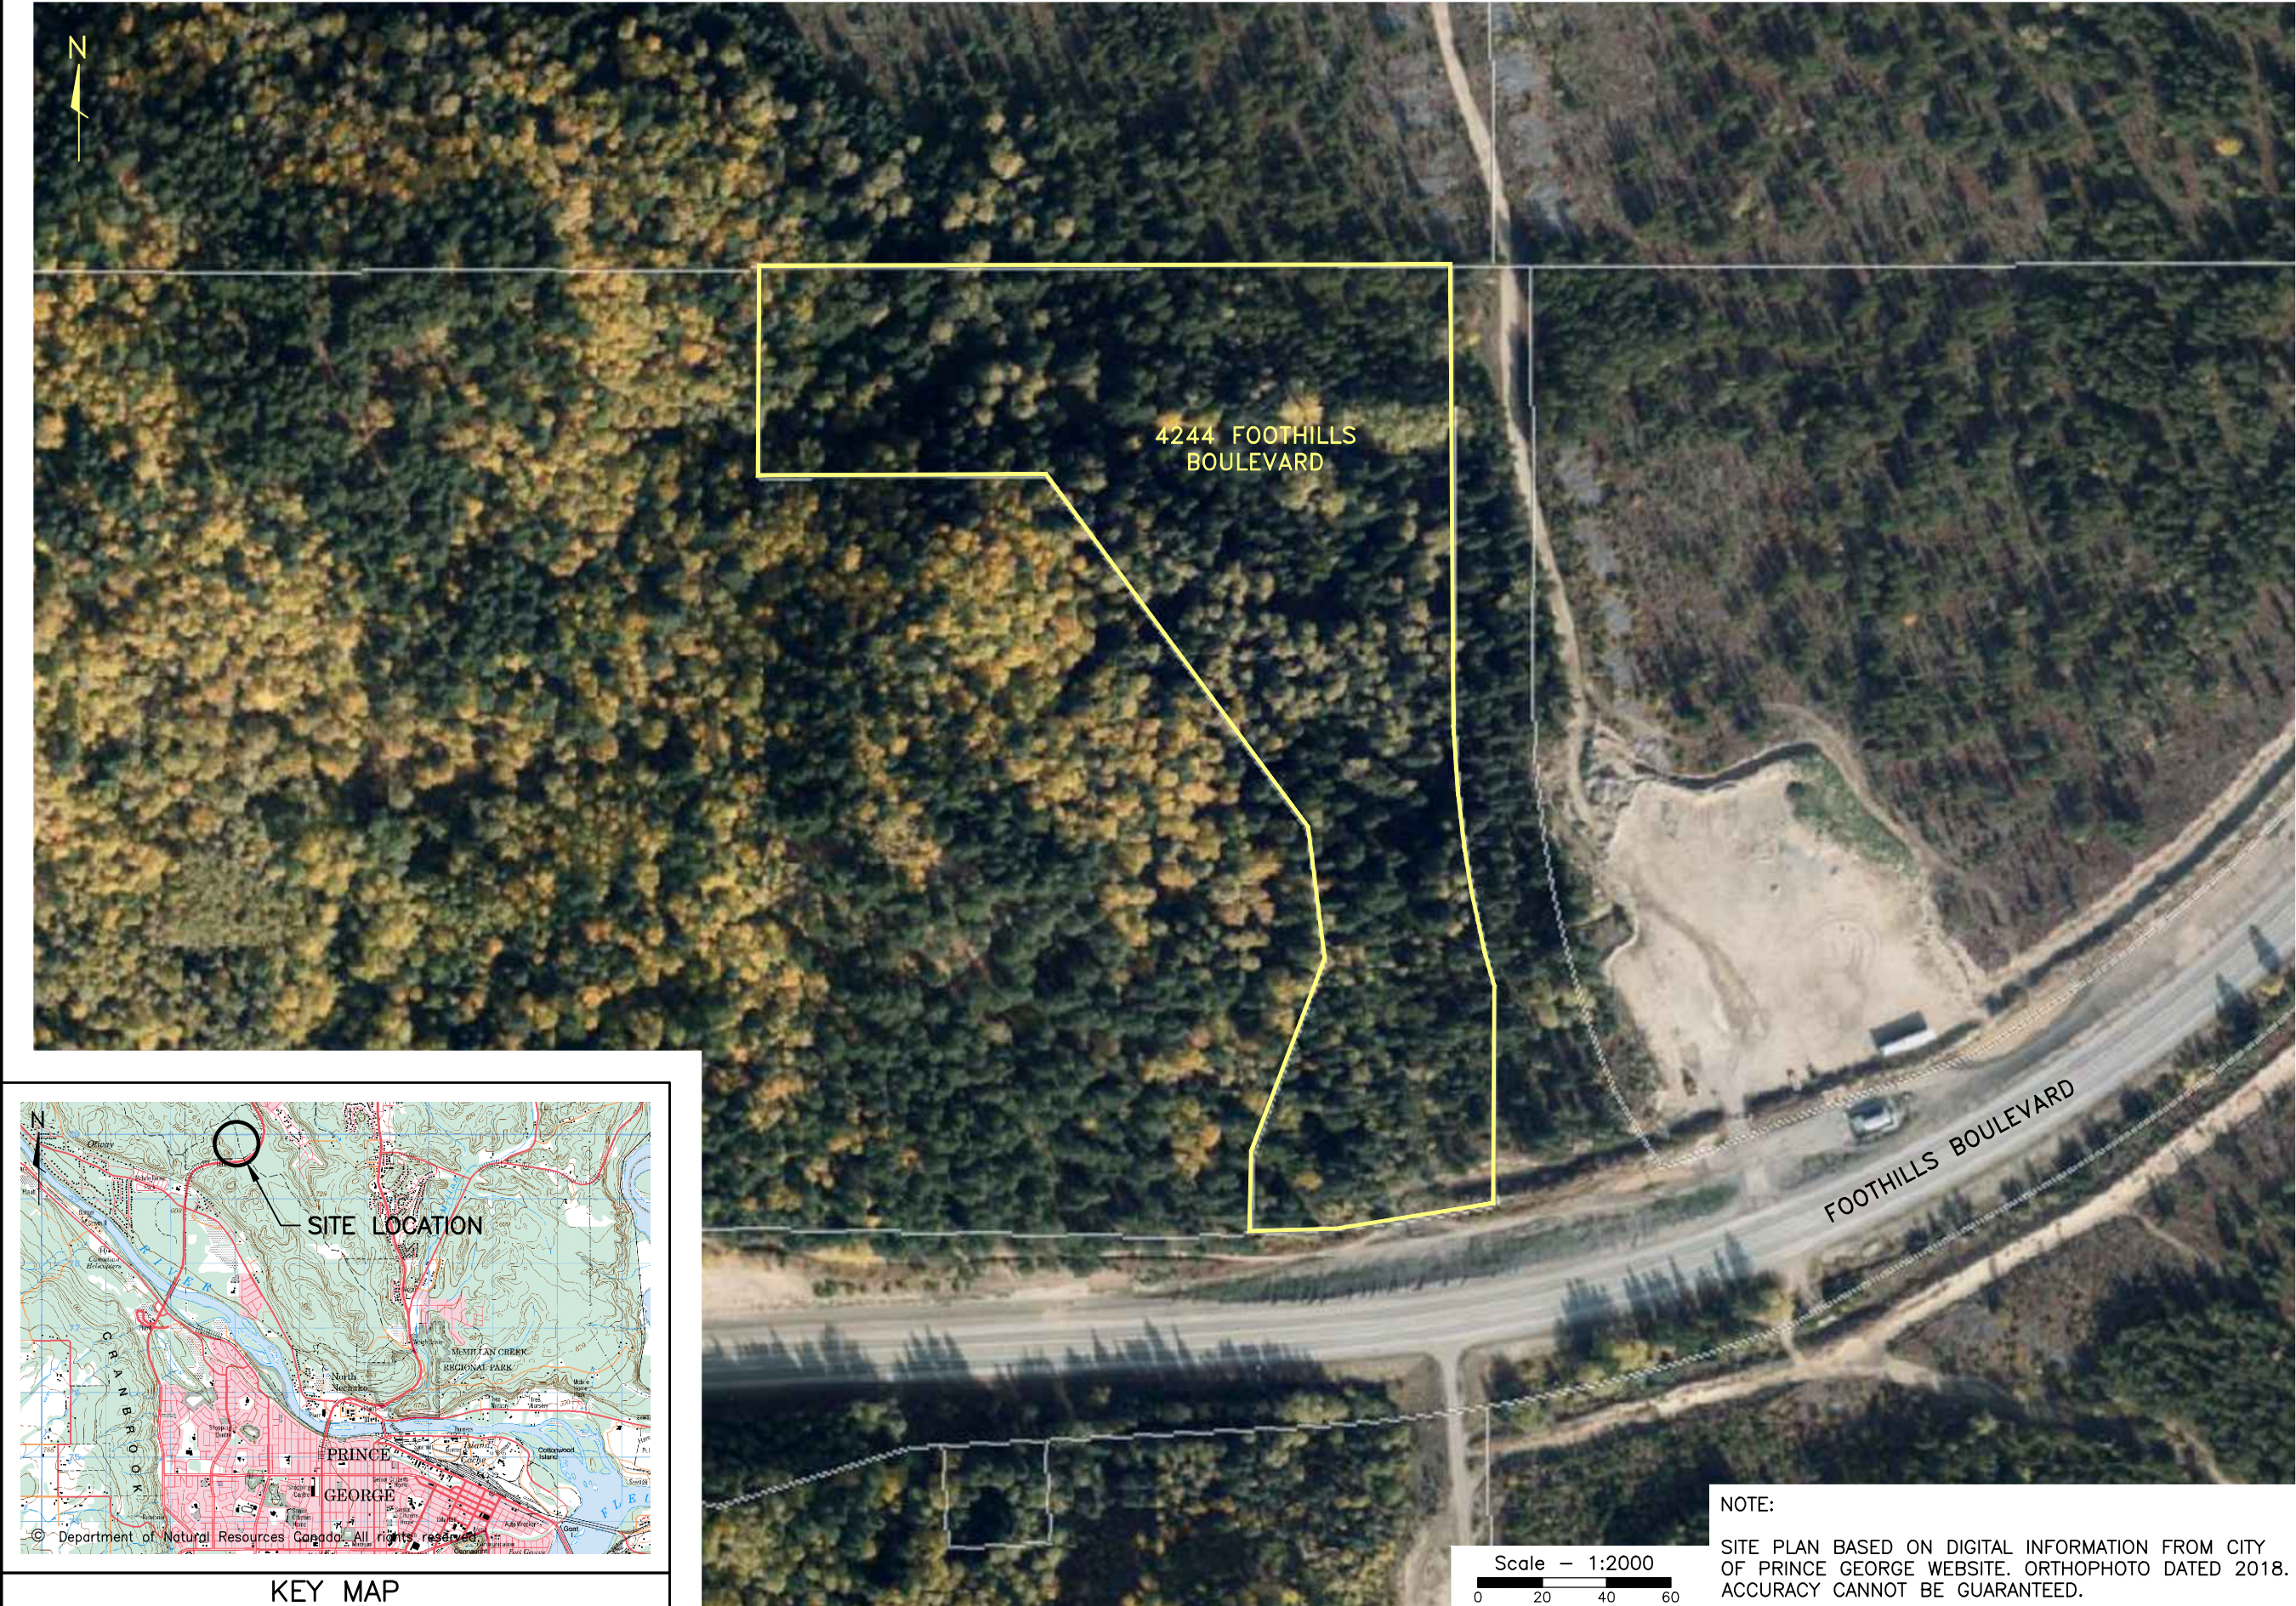
The property is located adjacent to Foothills Boulevard, about 1.2 km northeast of the intersection of North Nechako Road and Foothills Boulevard. It is “L” shaped, with the long axis oriented north to south and measuring about 290 m and the short axis measuring 215 m, oriented east to west at the north end of the long axis. Currently, the east part of the property is zoned Agriculture & Forestry (AF) and the west part is zoned Greenbelt (AG). You would like to expand the AF zoning over a larger part of the property. A plan showing the site location and current zoning is on Drawing 5302-A1, attached.

The transition in zoning between AG and AF at the time of writing does not follow a property line, a drainage, or terrain feature and seems to be arbitrary. From a geotechnical perspective, we recommend revising the zone boundary to that shown on Drawing 5302-A2.
