STAFF REPORT TO COUNCIL

DATE: January 29, 2021

SUBJECT: PG Playhouse Building Envelope Failure Update

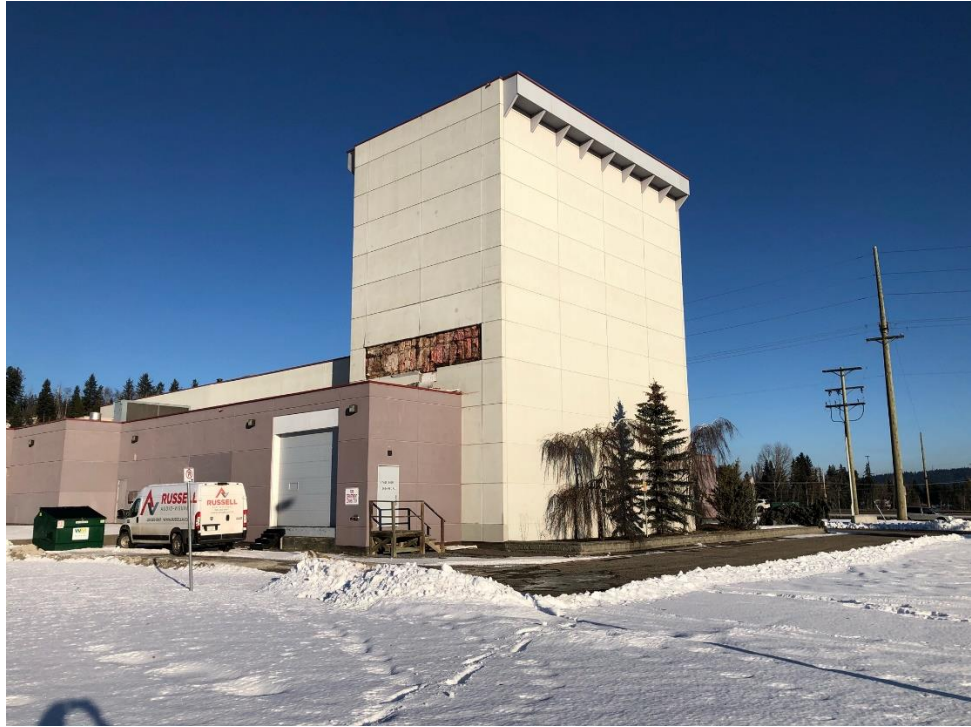
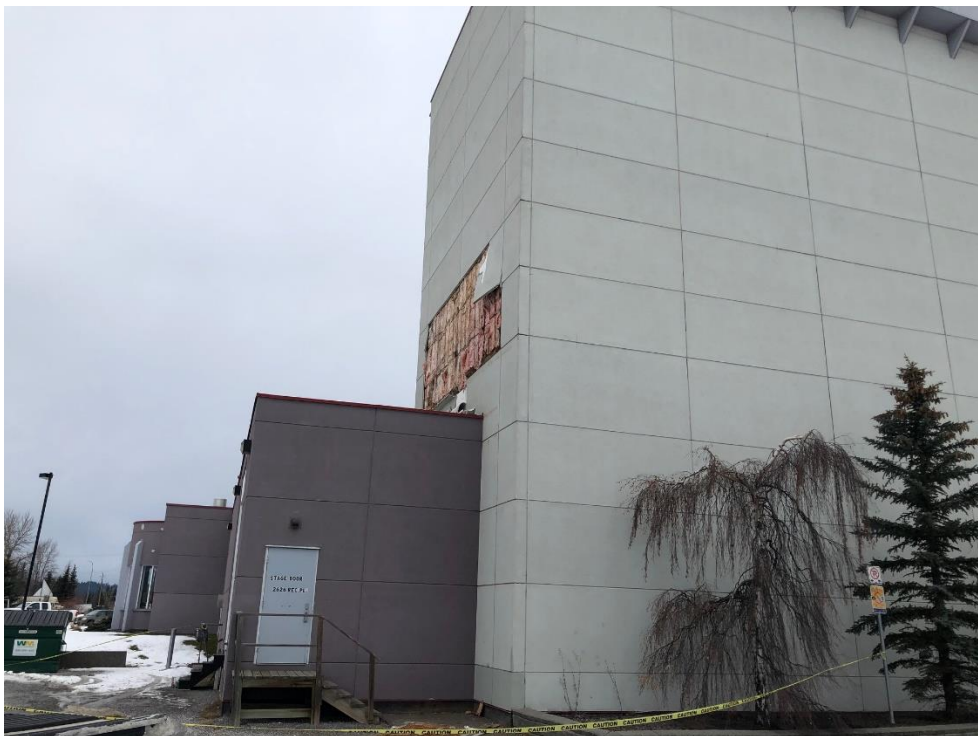
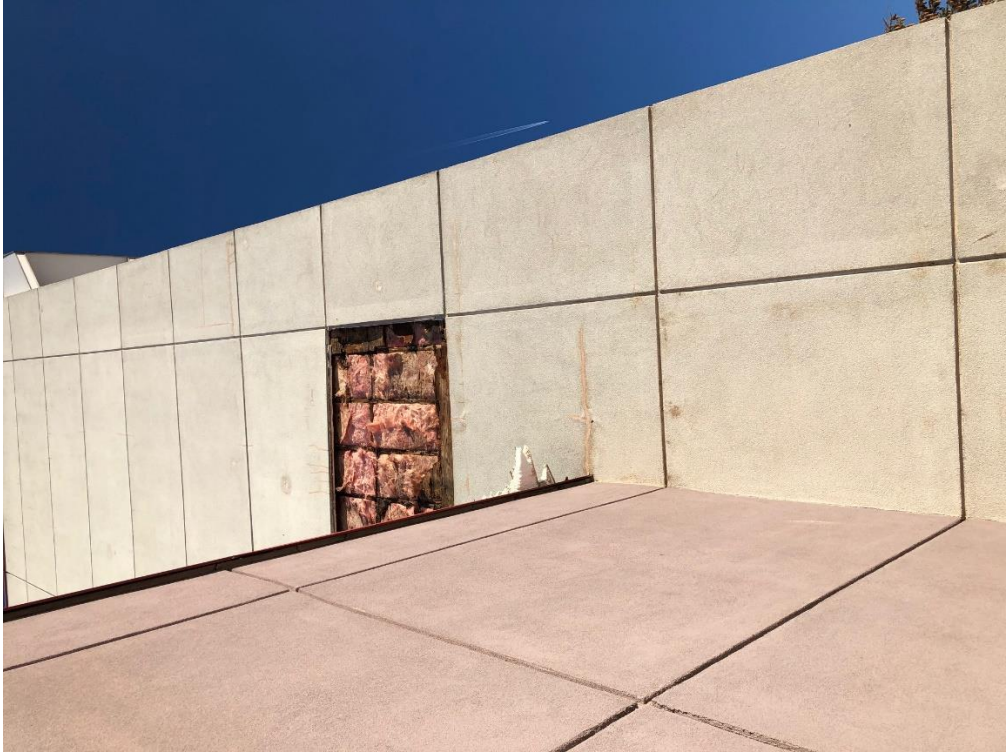
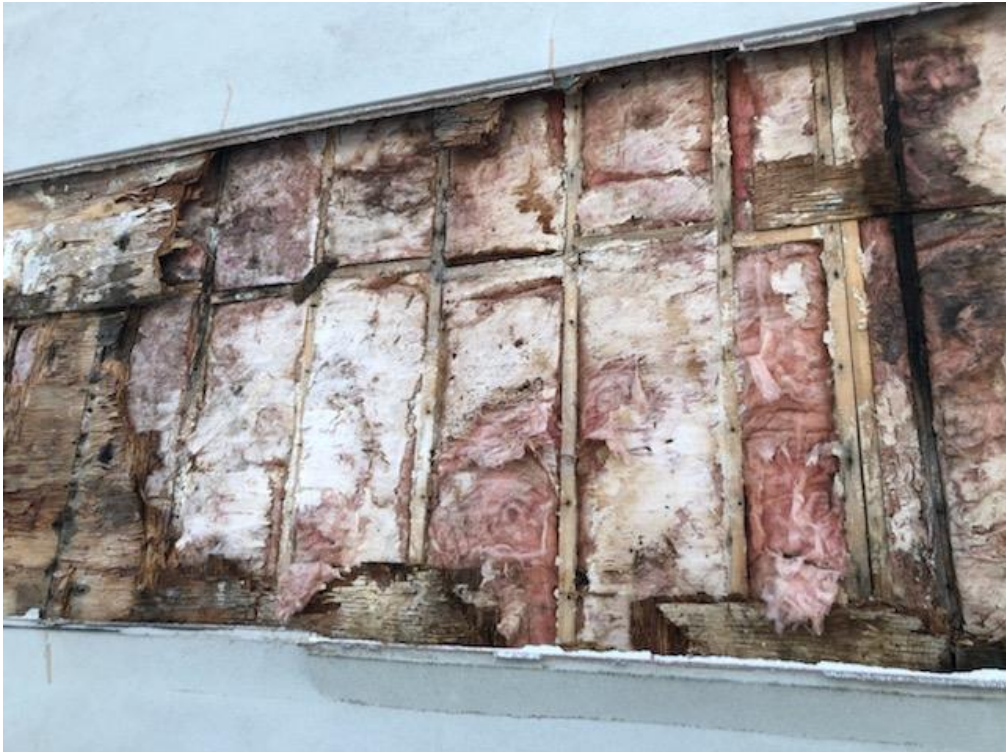
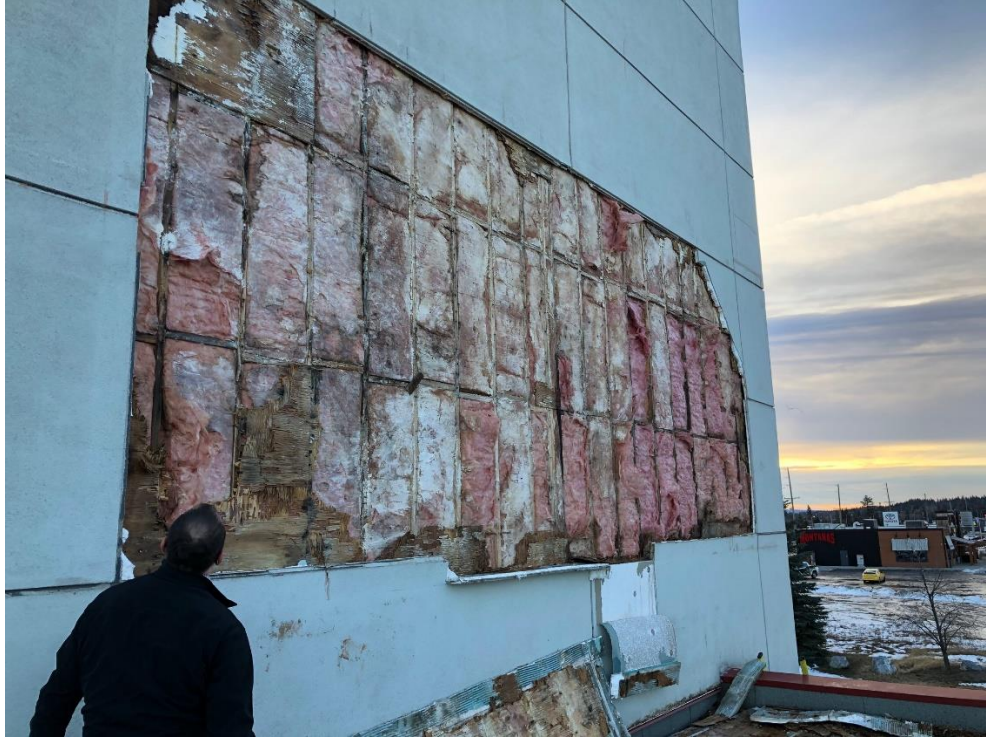
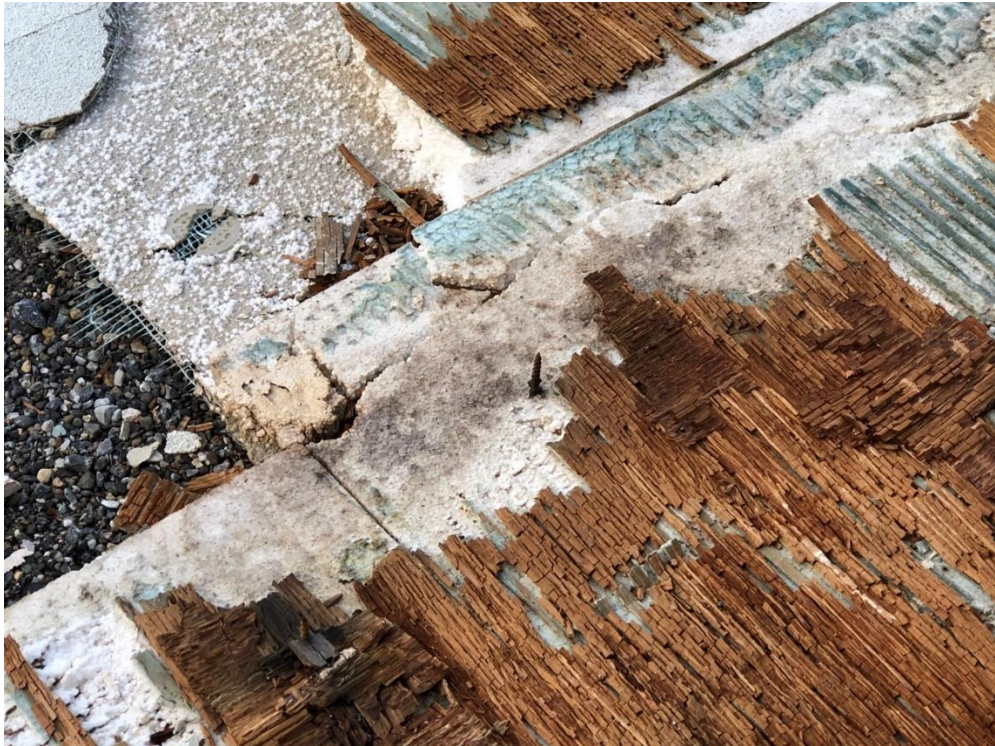
On December 4th, 2020, the Facility Maintenance Division informed Administration that a portion of the stucco cladding on the PG Playhouse fell off onto the lower roof and nearby ground. Initially, the site was barricaded off and made safe while a local contractor was employed to perform a preliminary inspection and complete interim repairs. That work was started in December but by early January 2021 it became apparent that the existing envelope condition, specifically, rot was very extensive and beyond minimal repair. It was then determined the best course of action was to protect the west façade of the PG Playhouse from the elements through heating and hoarding methodology and procure a building envelope specialist. The building envelope specialist will provide a current condition assessment of the entire building exterior. The inspection will include a type of testing, typically called pull testing or adhesion testing. It is used to measure the adhesion of the cladding material to the existing plywood substrate. Moisture penetration that cannot escape, will typically cause the rot issues and weaken the bond between the exterior panel and substrate. Modern cladding systems are designed to the "Rain Screen Principle" which allow moisture to escape. The photos below reflect the stucco façade failure experienced in December 2020:

The building envelope specialist has been secured and has indicated the condition assessment will commence in early February 2021, weather dependent. An inspection report will follow and Administration will update Council on the results of the condition assessment, both interim and long term repair strategies and associated cost estimates for repairs and renewal. Currently, the west façade of the PG Playhouse is protected from the elements through heating and hoarding methodology.
